# GRIGGS AND WALNUT GROUND WATER PLUME SUPERFUND SITE STATUS UPDATE

Community Meeting  
Branigan Library, 200 East Picacho  
September 25, 2019

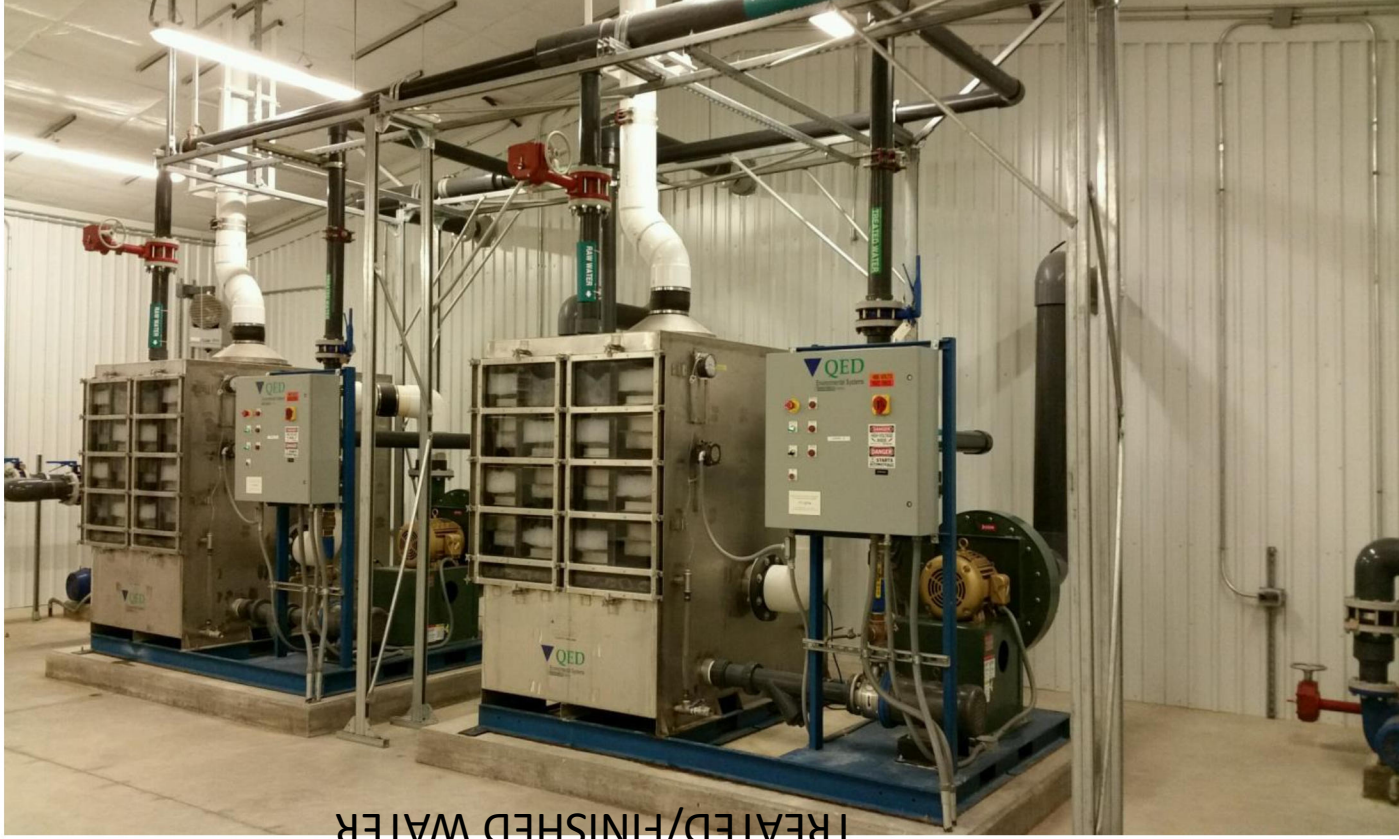
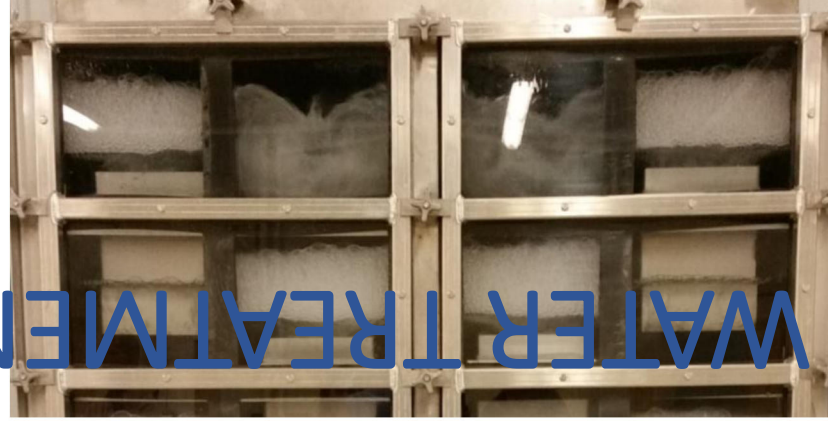
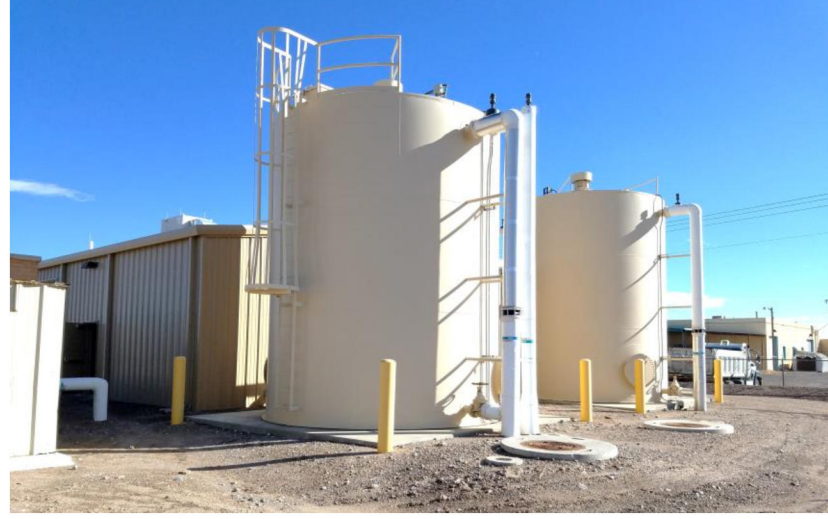
# WATER TREATMENT PLANT

TWO 28,000 GALLON HOLDING TANKS  
EXTRACTED/RAW WATER AND  
TREATED/FINISHED WATER

STACKED-TRAY AIR STRIPPER WATER TREATMENT SYSTEM

ENLARGED PHOTO OF STACKED TRAYS

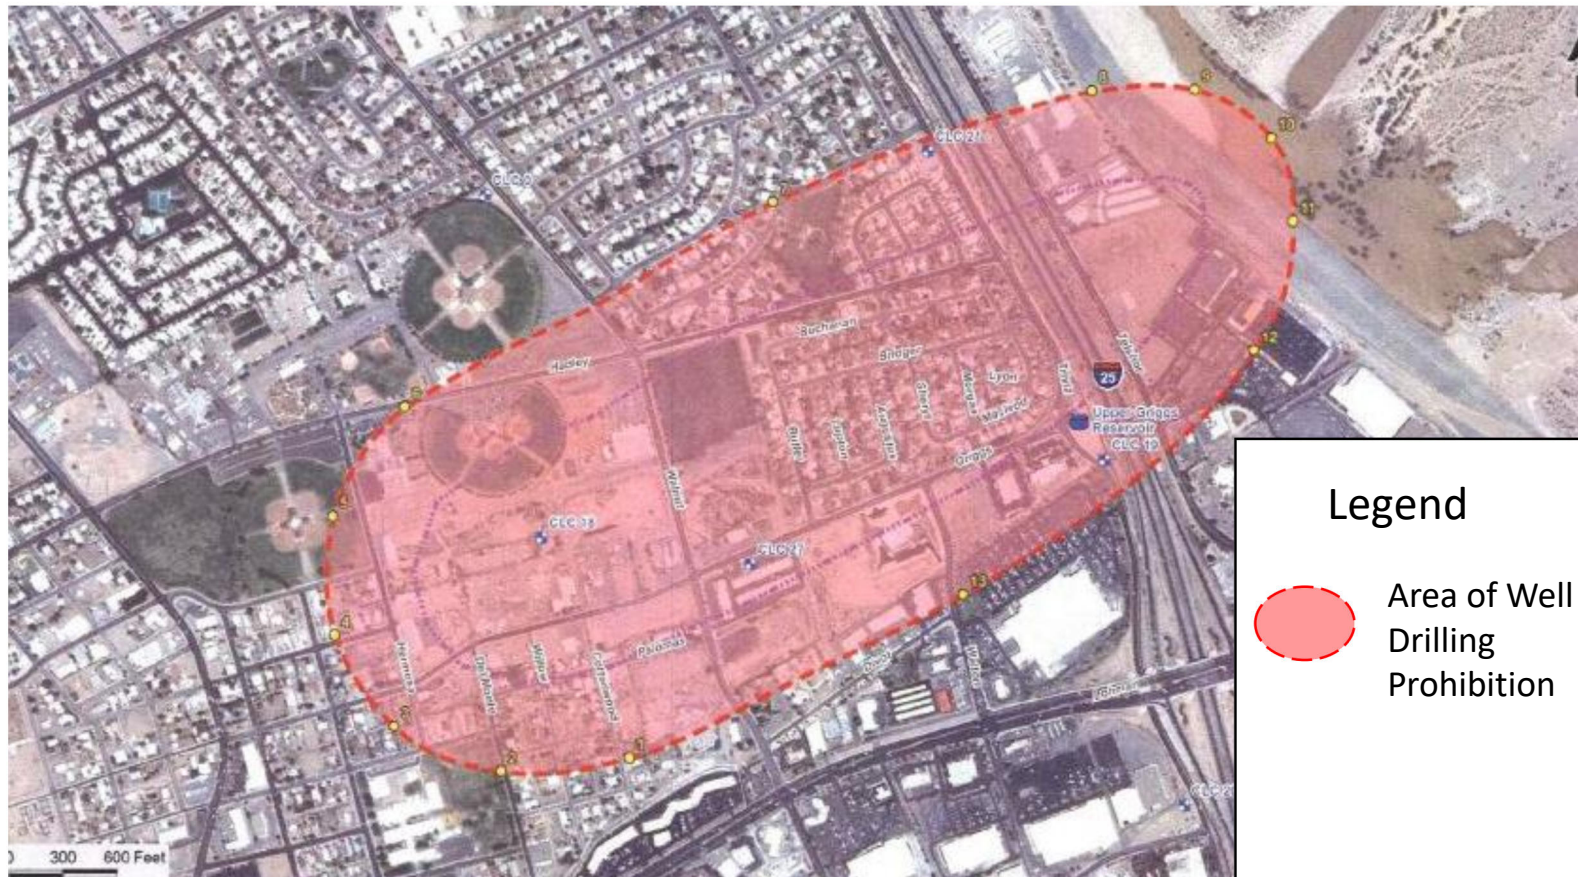
- Monitor well
- Public supply well
- Inactive public supply well
- 6" raw water line
- 8" finished water line
- Treatment compound
- Existing 10" water line to reservoir

- PCE concentration contour (µg/L), upper
- PCE concentration contour (µg/L), lower (dashed where inferred)
- CLC Pumping Well

GRIGGS-WALNUT GROUND WATER PLUME SITE  
REMEDIAL ACTION  
PCE in Groundwater, December 2018

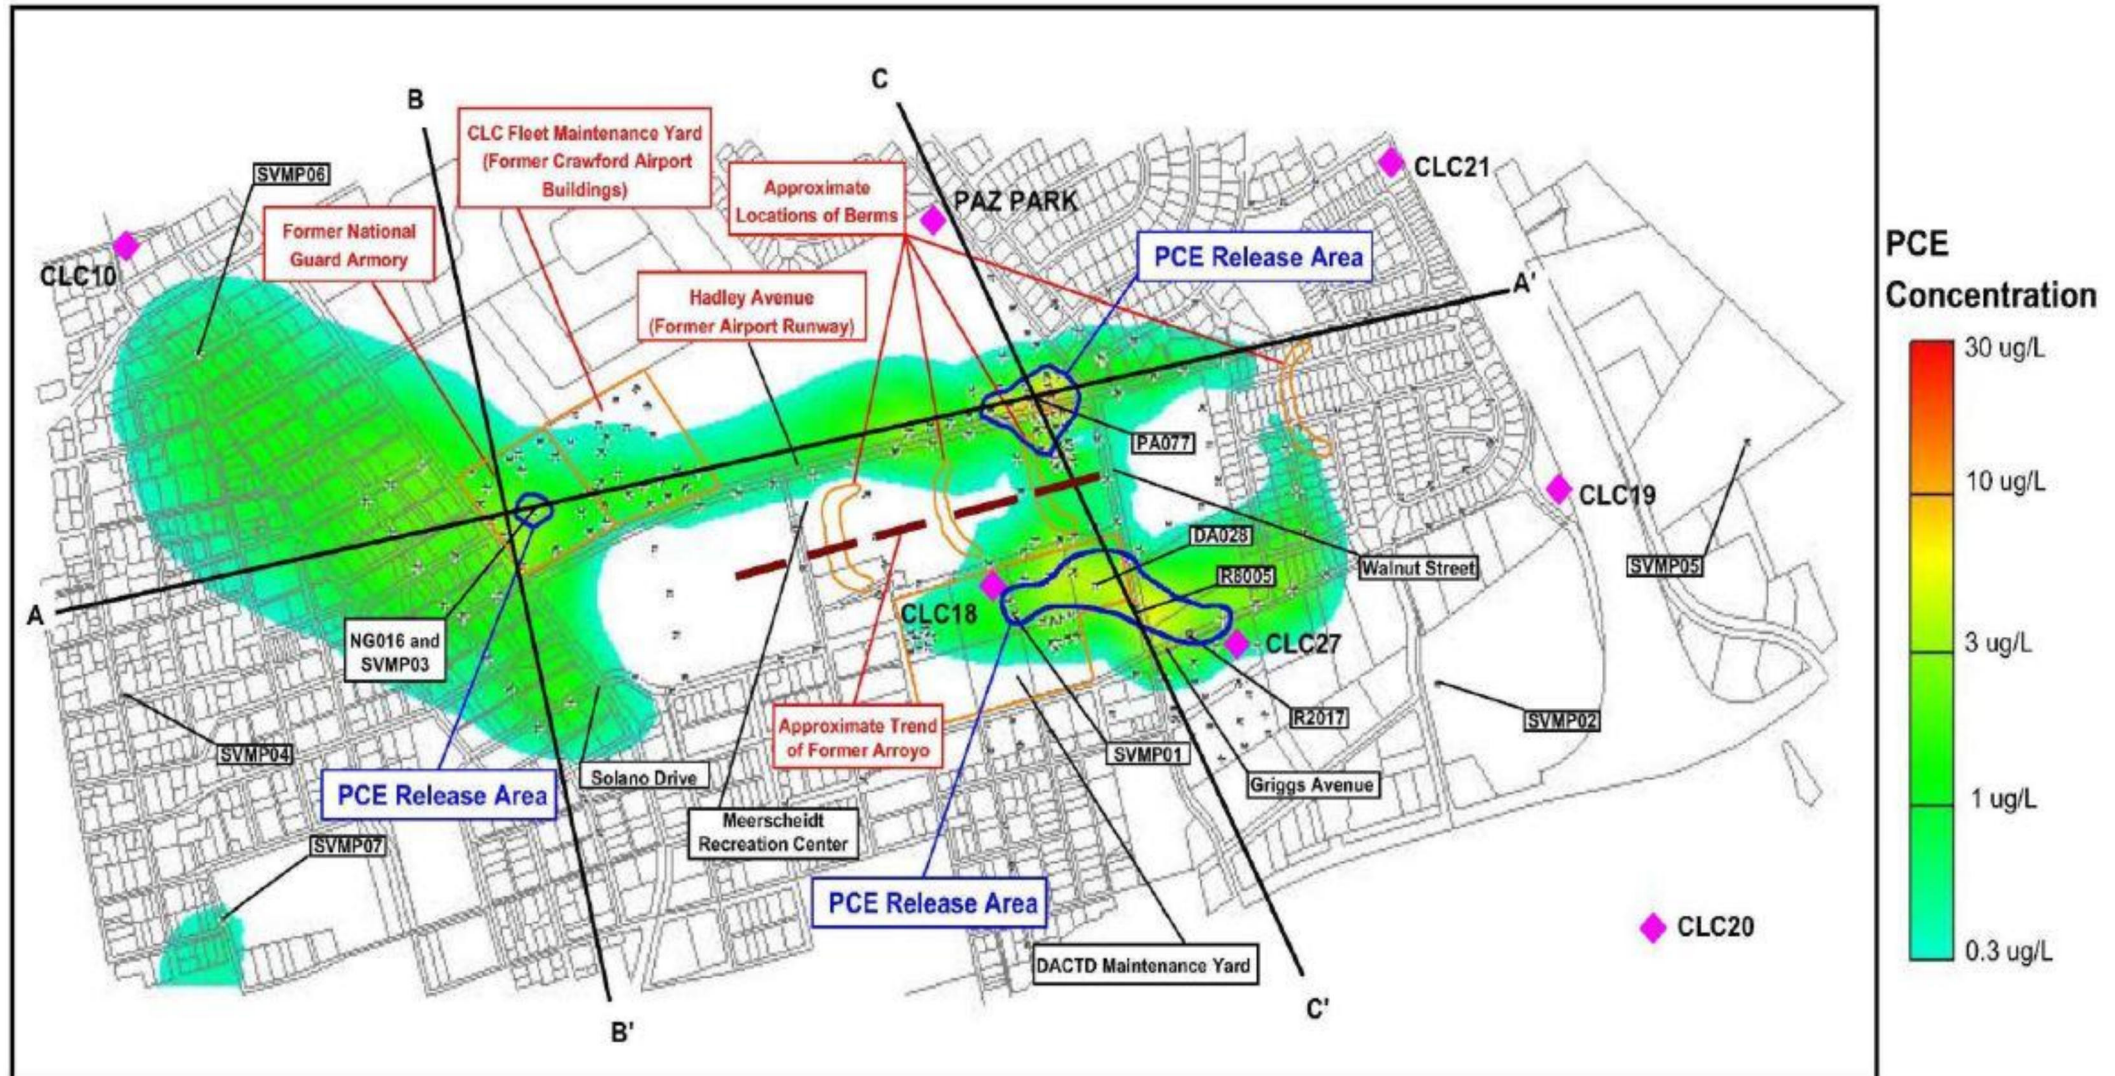
# HORIZONTAL DISTRIBUTION OF PCE IN SOIL GAS

*EPA 2005 REMEDIAL INVESTIGATION*
