PICACHO HILLS DRAINAGE MASTER PLAN

MARCH 2009

Dona Ana County Flood Commission
845 N. Motel Boulevard
Las Cruces, NM 88001

Bohannan Huston, Inc.

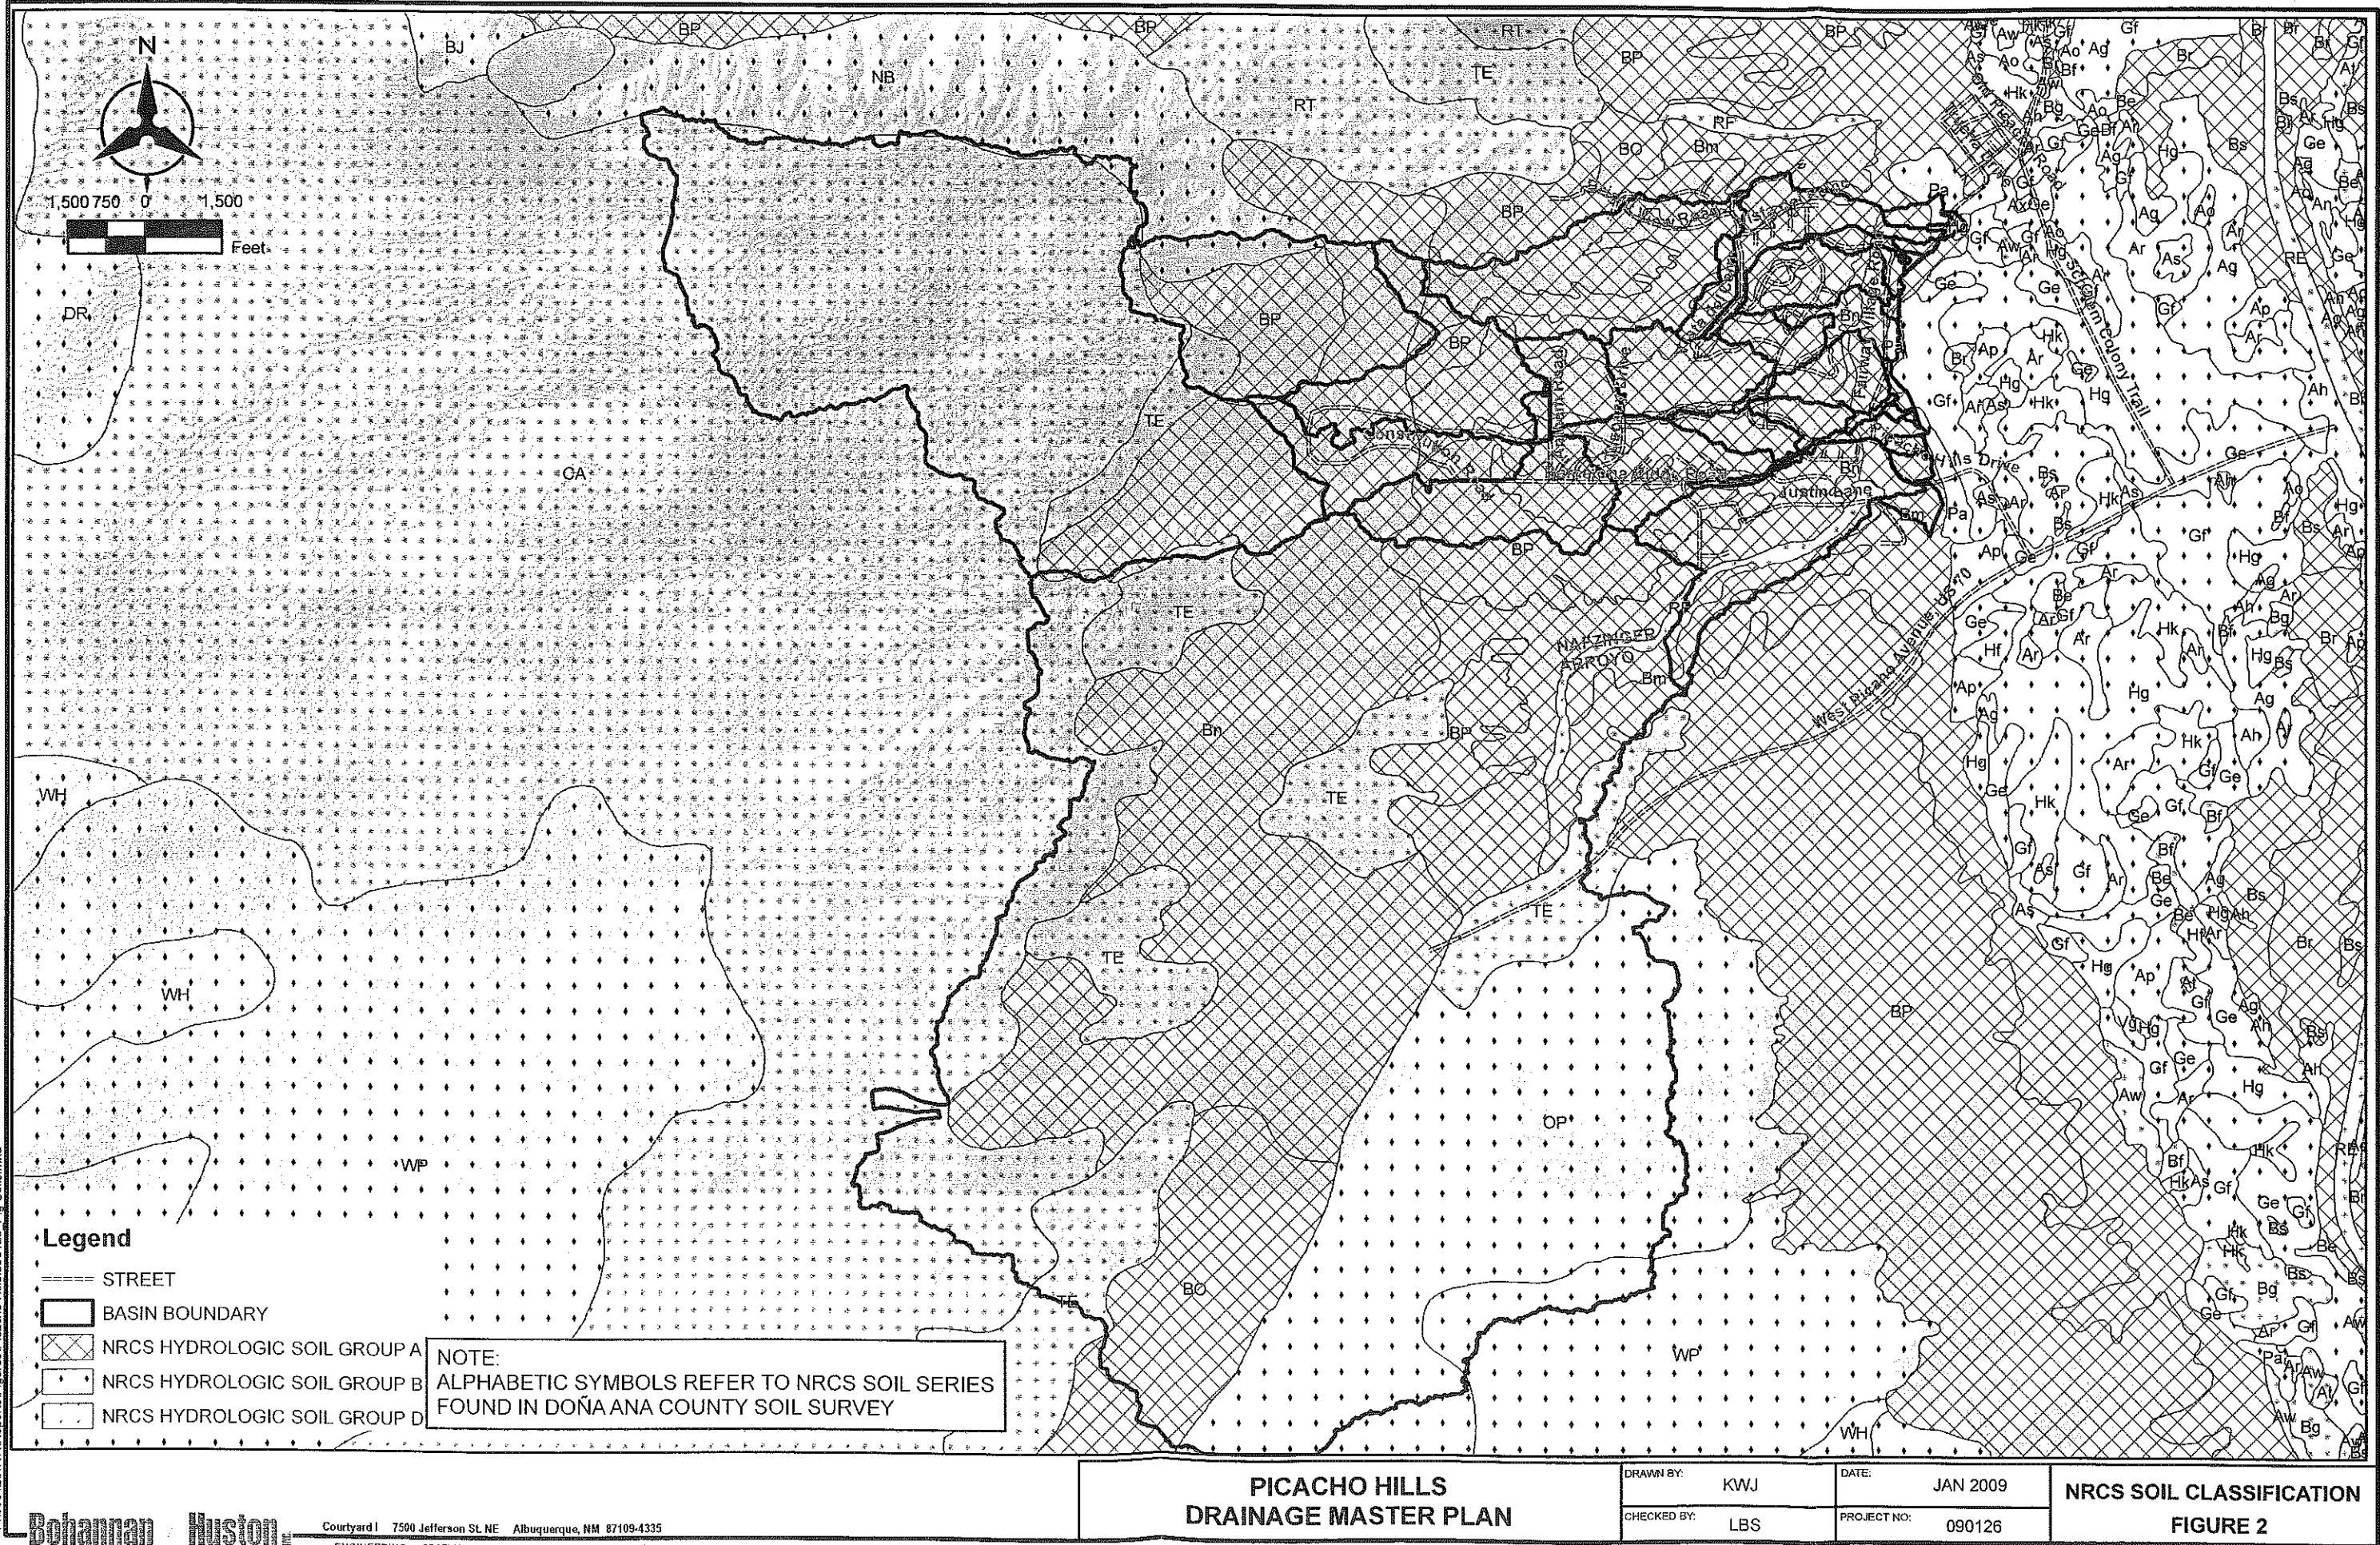
Soils within the Picacho Hills area include Group A, B and D soils with the majority of the soils being Group A soils. Group D soils are principally finer grains and are characterized by lower infiltration rates; these soils are found principally on the western mesa top. **Figure 2 – NRCS Soil Classification**, is a graphical representation of the soil distribution throughout the study area.

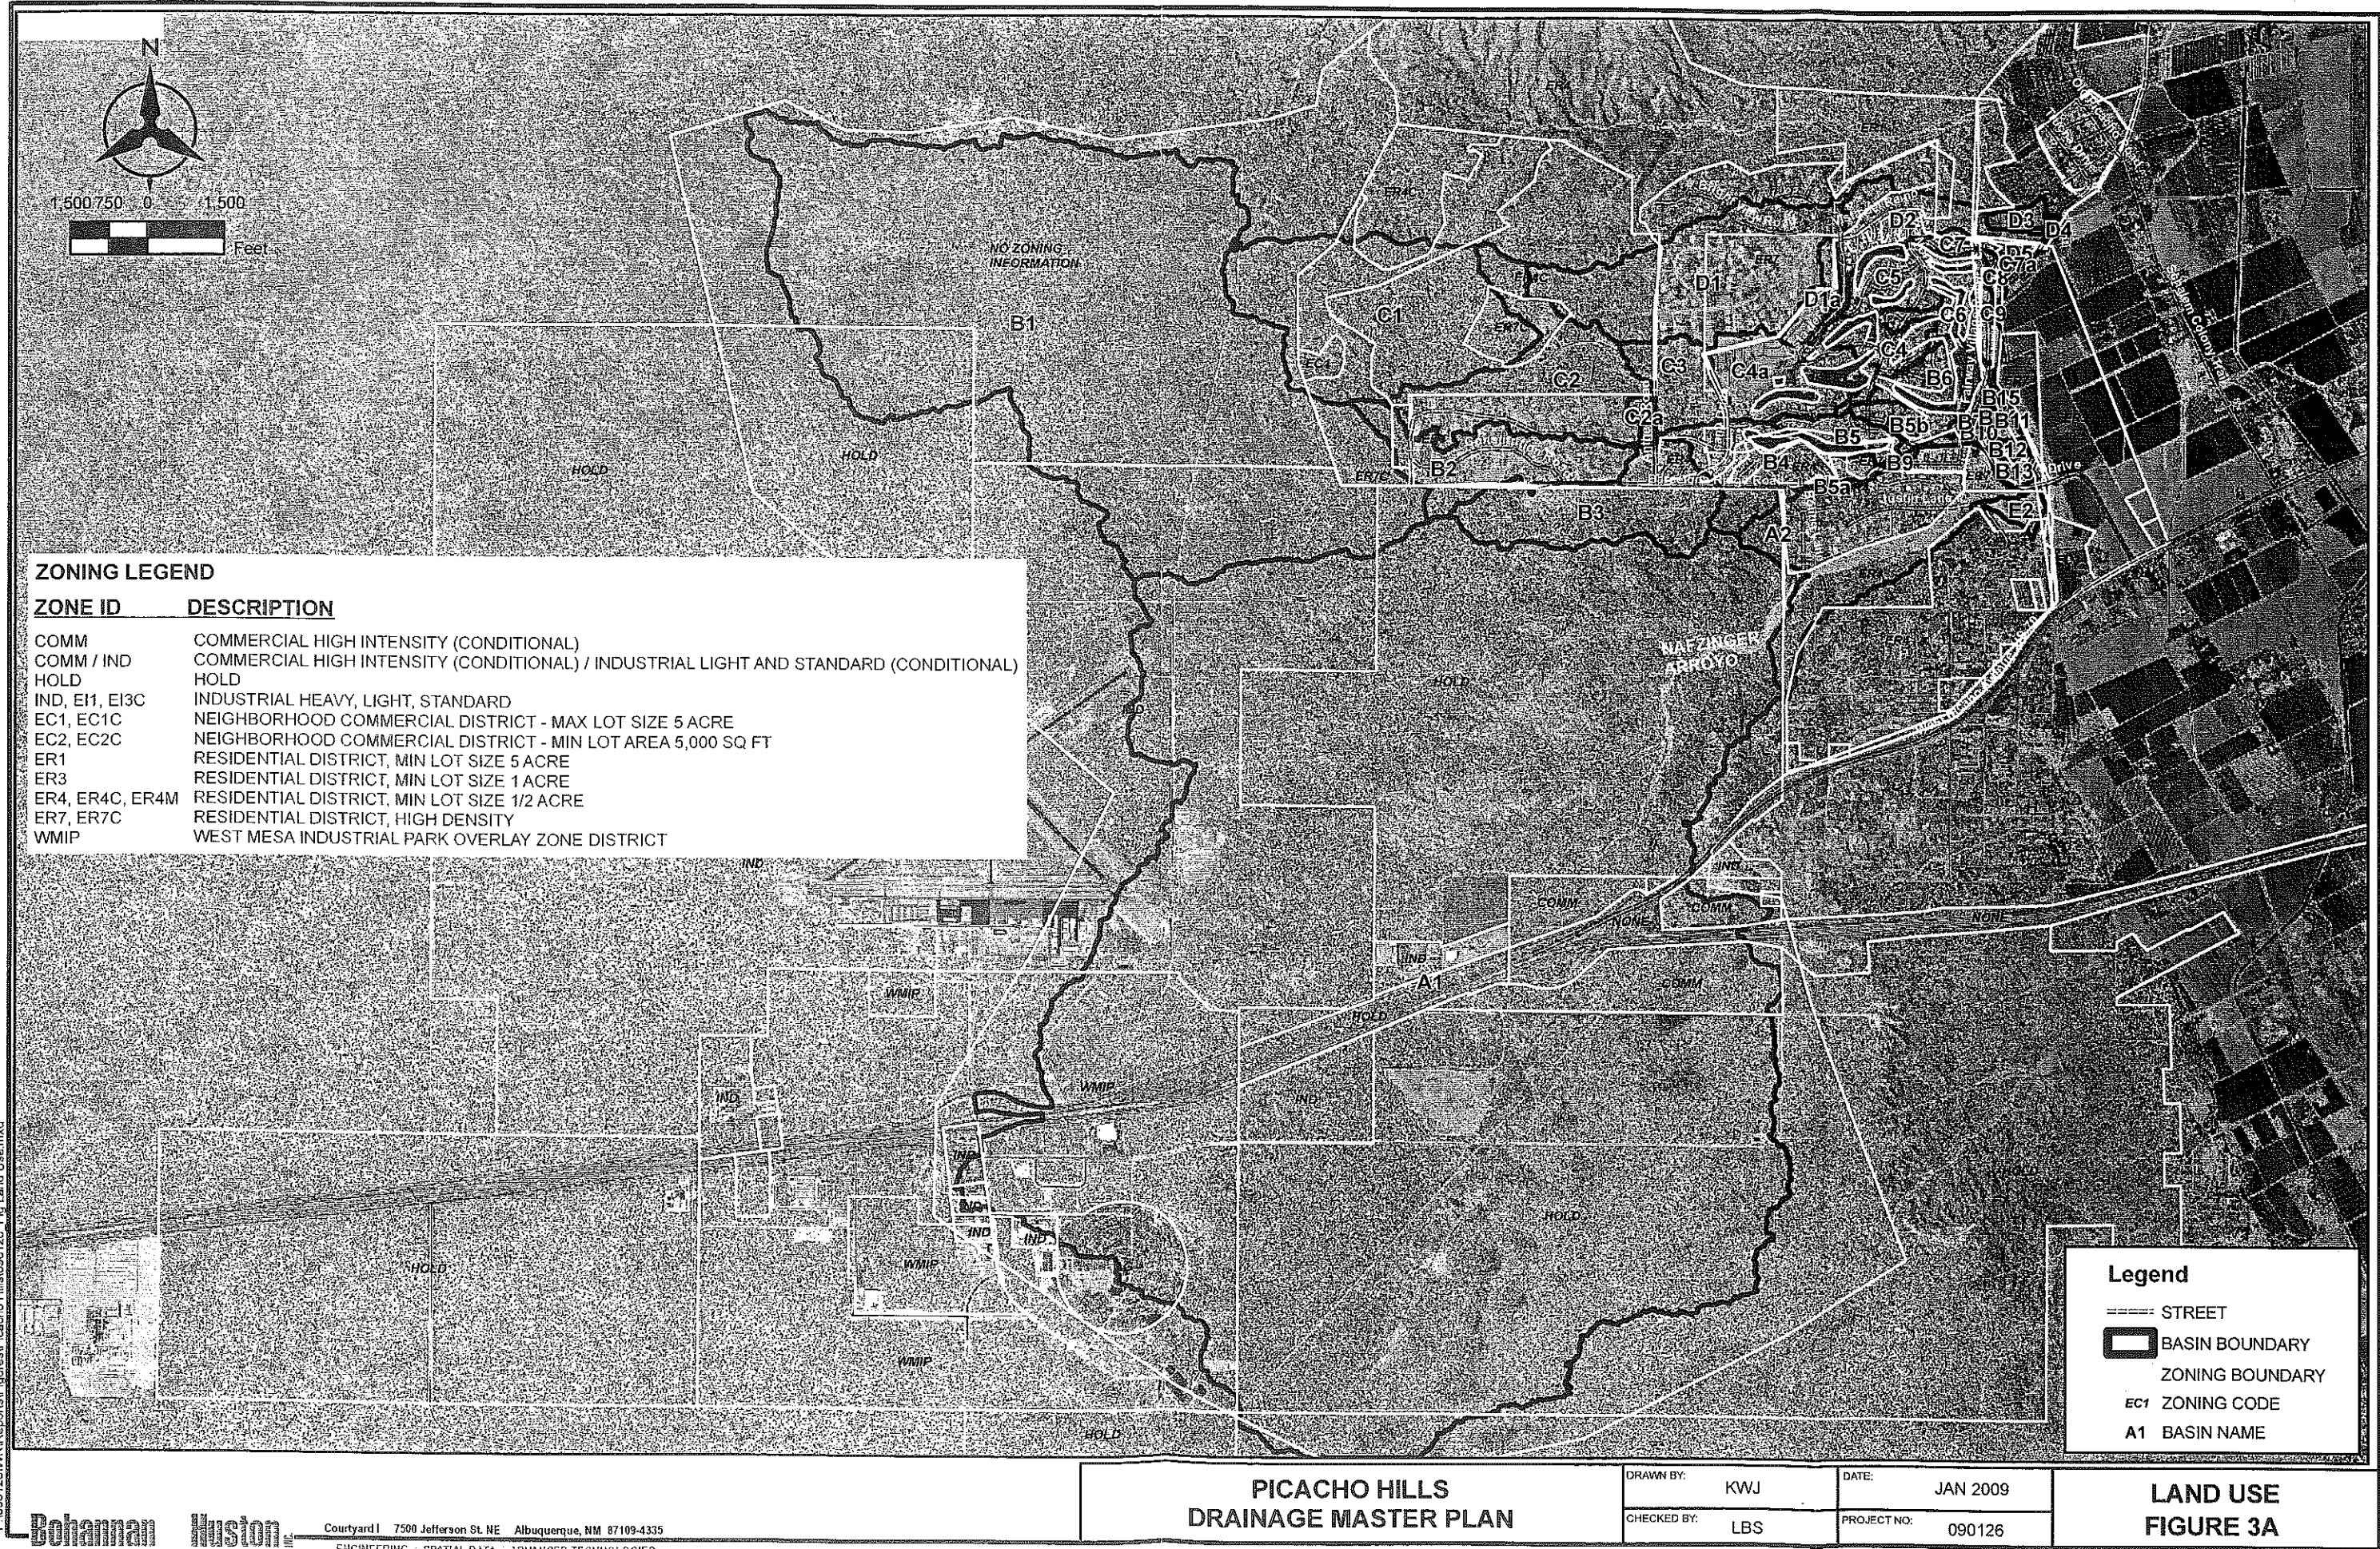
Those basins and sub-basins outside of the currently developed area of the Picacho Hills community were assessed based upon the current property zoning to assess future fully developed conditions. Using the current zoning information for these undeveloped areas added four additional land usages: Residential-4 acre lot, Residential-1/2 acre lot, Commercial/Business, and Industrial. **Figure 3A: Land Use** and **Figure 3B: Land Use Tables** provide additional information.

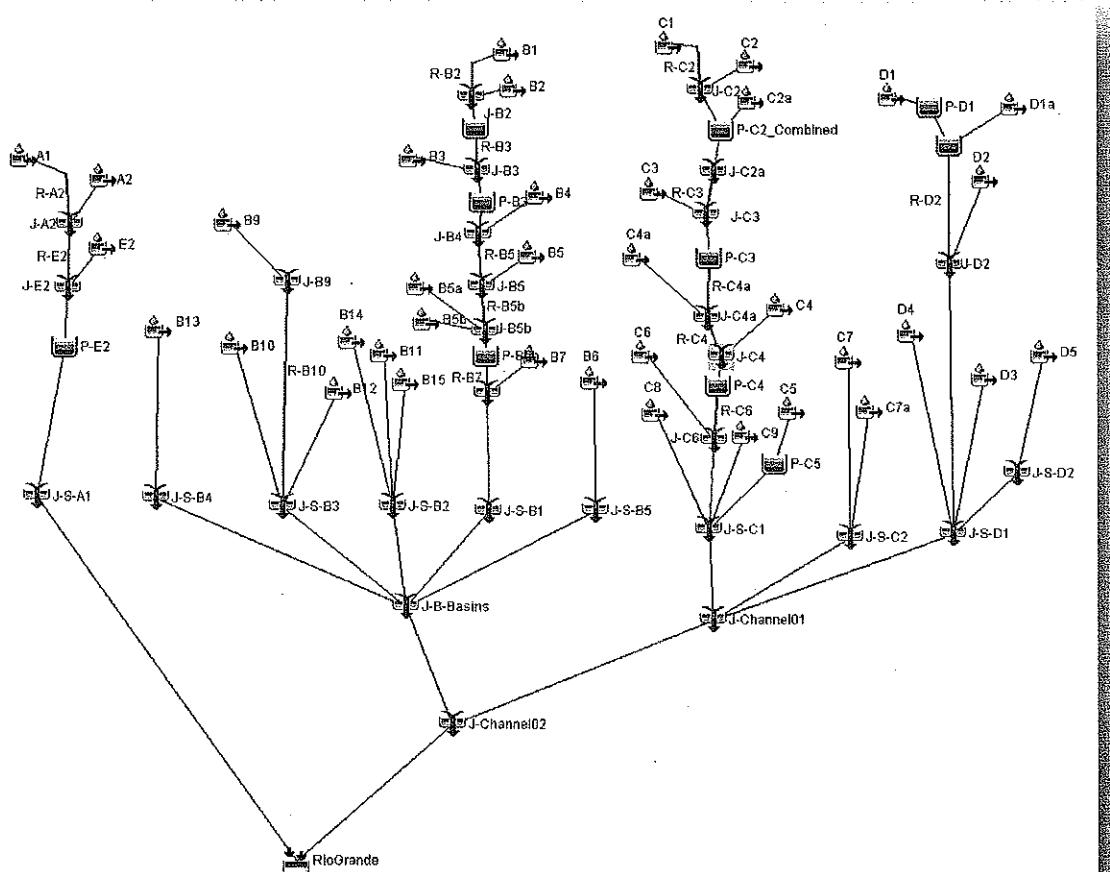
Figure 6 - Hydrologic Model Schematic

A hydrologic model was prepared for the Picacho Hills community and contributing offsite drainage basins for existing conditions. The existing conditions model represents conditions on the ground as of the 2007 aerial mapping activity. Major regional ponding areas were analyzed, while small local ponding areas and on-lot ponding were not included in the analysis. The basin schematic is shown on **Figure 6:**

HEC-HMS model include existing pond enhancement and the inclusion of new ponding areas. Detention ponds like these are critical to attenuating storm flows within downstream arroyos. Improving the functionality of pond spillways and increasing the storage volume of existing ponding areas will improve how the pond attenuates storm flows. Only the major ponding areas were included in the HEC-HMS models. Small ponding areas and on-lot ponding were not included. The final future condition model includes all proposed improvements to the drainage system; these improvements are discussed later in the report. The basin schematic is shown on **Figure 6: Hydrologic Model Schematic**.

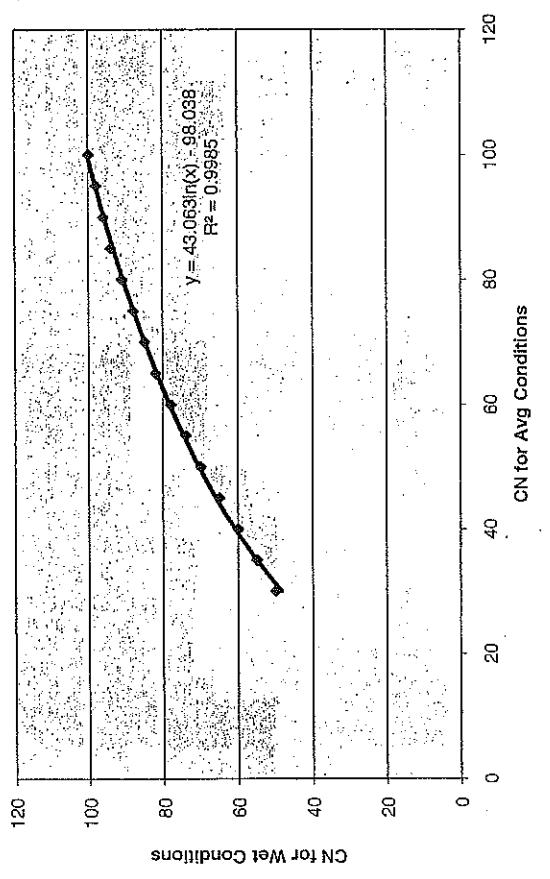
CN Conversion from Antecedent Moisture to Wet Conditions

- Curve numbers increased / adjusted to represent the high antecedent moisture content for modelling purposes.
- Curve numbers adjusted per USDA SCS TR-55, 1986 (As found in table 3-5 NMDOT Drainage Manual, pg. 3-27)

Table 3-5 - Conversion from Avg. Antecedent
Moisture Conditions to Wet Conditions
(NMDOOT Drainage Manual)

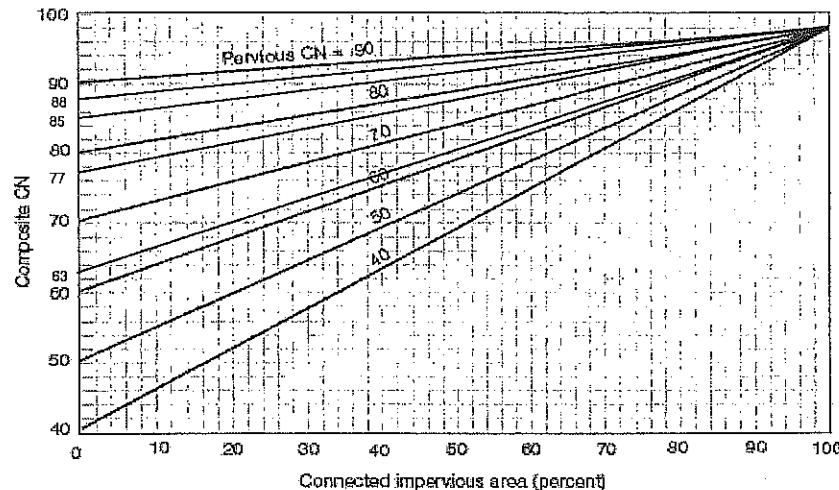
Figure 2-3 Composite CN with connected impervious area.

- Curve numbers increased / adjusted to represent increased impervious area due to development, per Figure 2-3 - Composite CN with connected impervious area (TR-

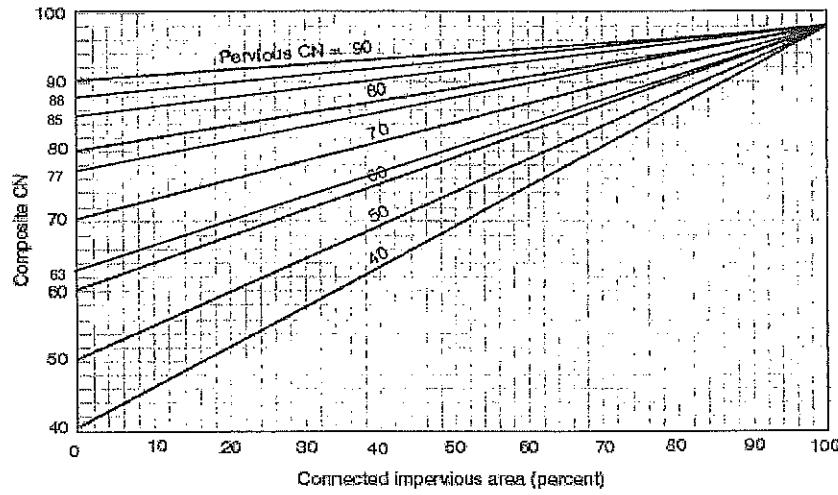
Figure 2-3 Composite CN with connected impervious area.

- Curve numbers increased / adjusted to represent increased impervious area due to development, per Figure 2-3 - Composite CN with connected impervious area (TR-55)

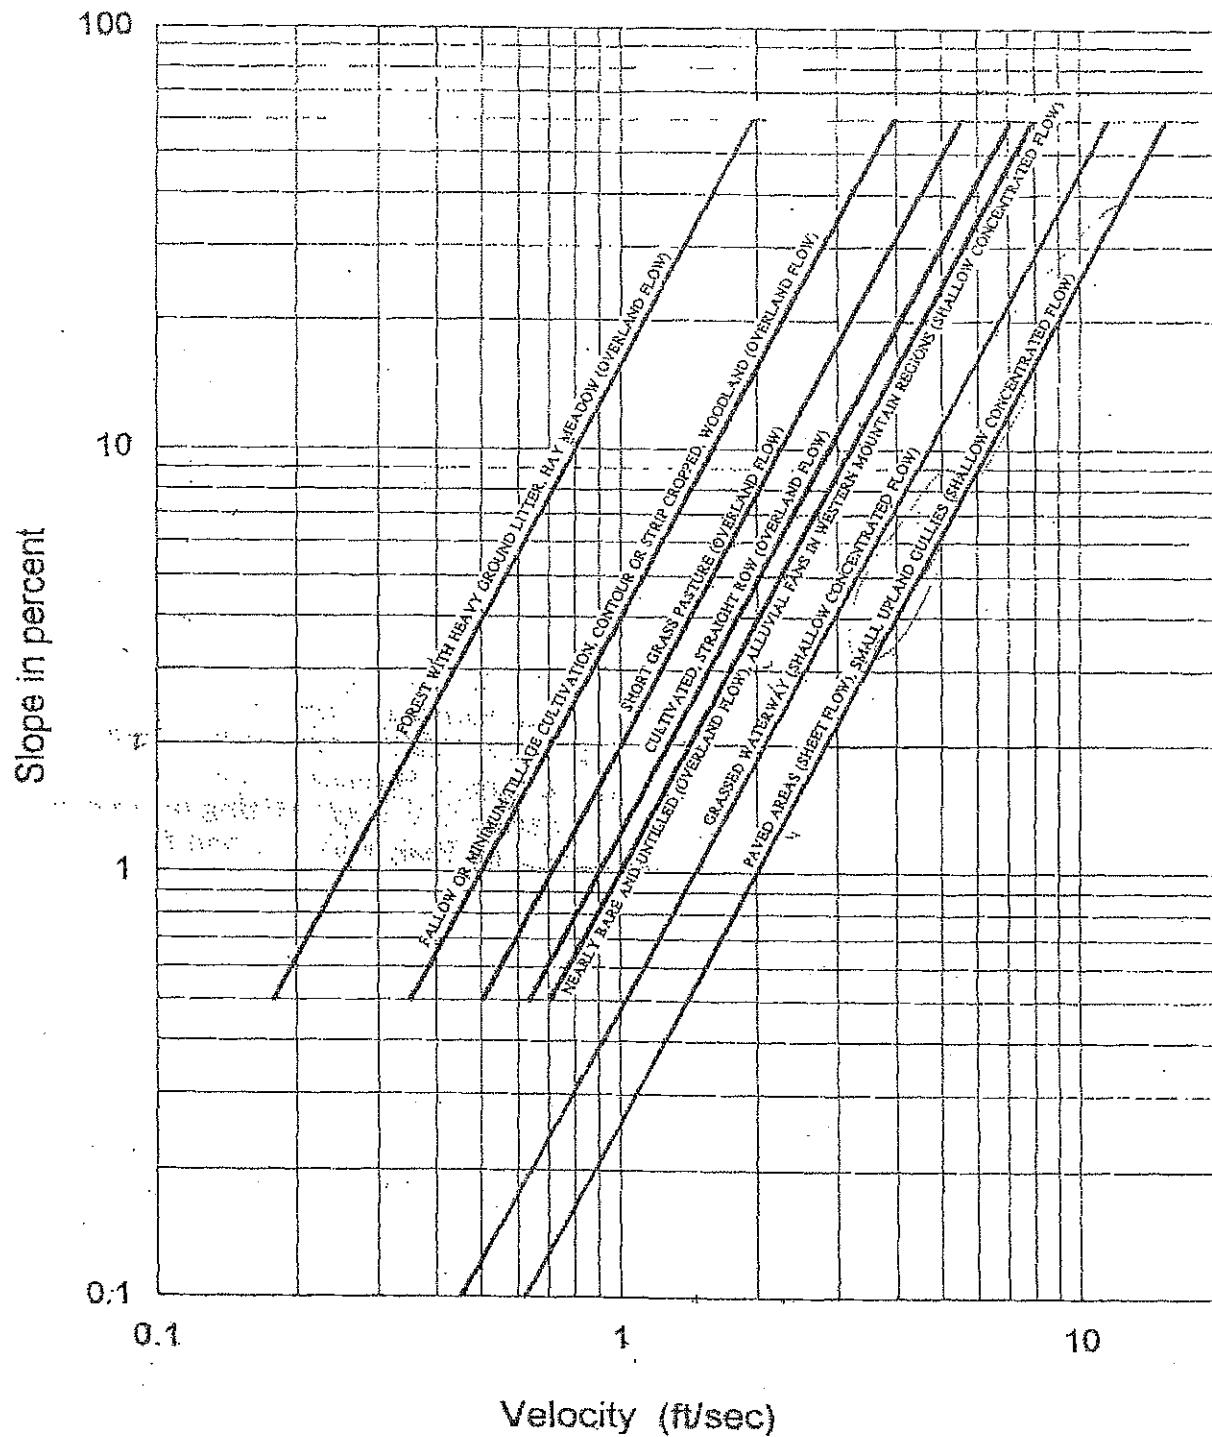
Reference: NMDOT Drainage Manual - Volume 1, Hydrology 1995

Note: For watercourses with slopes less than 0.5 percent, use the overland flow velocity given for 0.5 percent, except for shallow concentrated flow where a flatter slope may be considered.

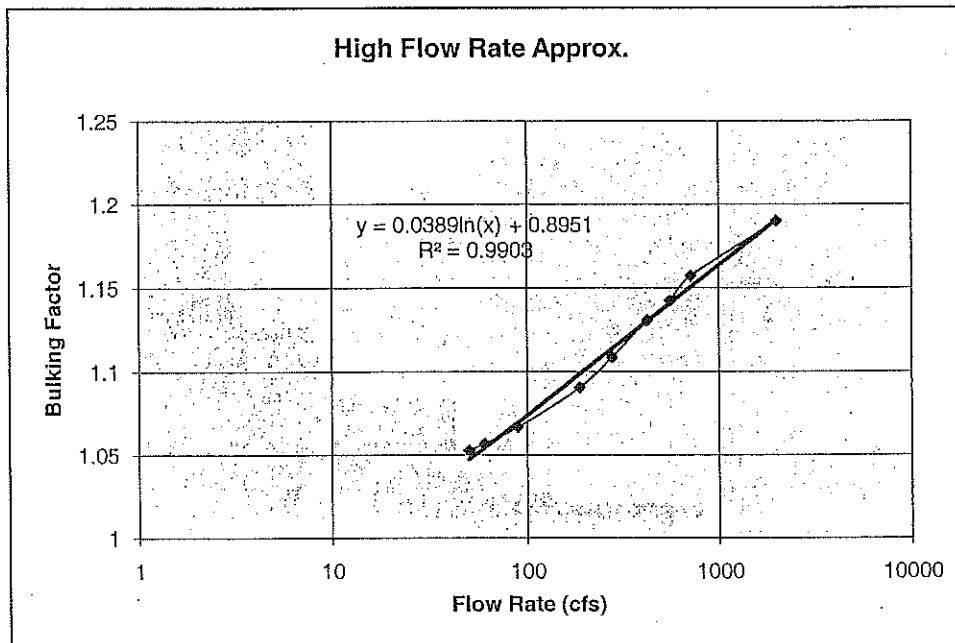
Existing Conditions Sediment Bulking Approximation

D50 = 0.5 mm	
Flow (cfs)	Existing/Proposed Conditions
2	1.0143
5	1.0203
10	1.0275
20	1.0364
50	1.0525
60	1.0567
89	1.0666
187	1.0904
277	1.1084
424	1.1307
558	1.1424
715	1.157
2000	1.19

Value approximated by Mussetter via phone conversation

The data presented within this report was utilized to approximate the sediment bulking factors utilized for the analysis of the Picacho Hills area. **Table 4: Sediment Bulking** summarizes the sediment bulking factors utilized during analysis. Detailed sediment bulking factor calculations are found in **Appendix A: Hydrologic Calculations**.

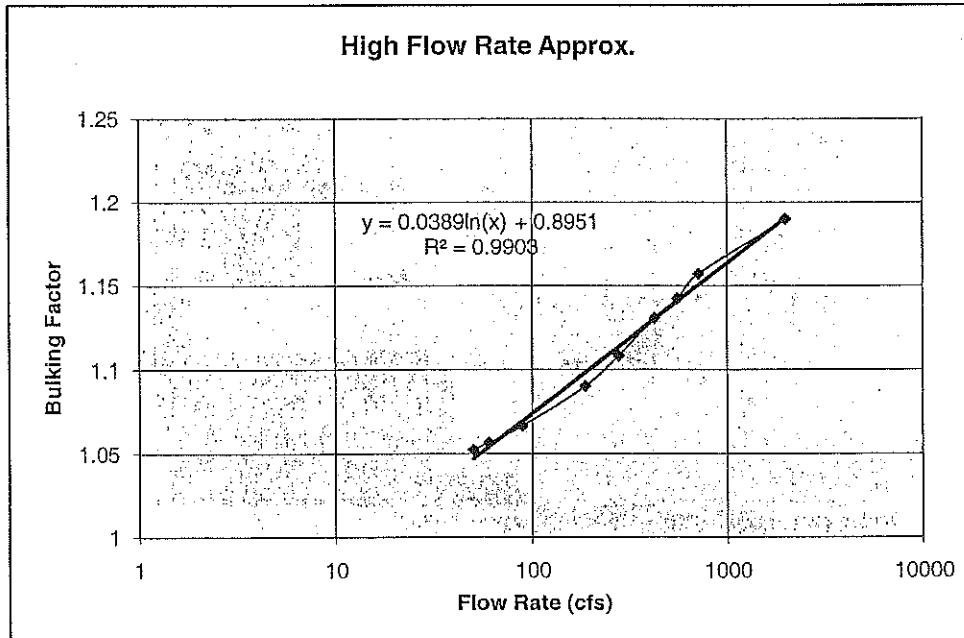
Future Conditions Sediment Bulking Approximation

Flow (cfs)	Existing/Proposed Conditions
2	1.0143
5	1.0203
10	1.0275
20	1.0364
50	1.0525
60	1.0567
89	1.0666
187	1.0904
277	1.1084
424	1.1307
558	1.1424
715	1.157
2000	1.19

Value approximated by Mussetter via phone conversation.

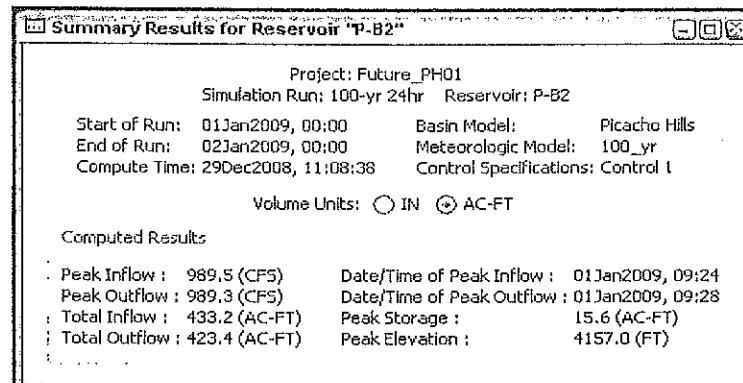
Total Storage Capacity	15.65 AC-FT
Dead Storage Capacity	8.87 AC-FT
Pond Top Elev.	4157 FT
Pond Invert Elev.	4139 FT
Principle Spillway	9-60" CMP Culverts
Culvert Inv. Elev.	4152 FT

Note: No flow overtop roadway.

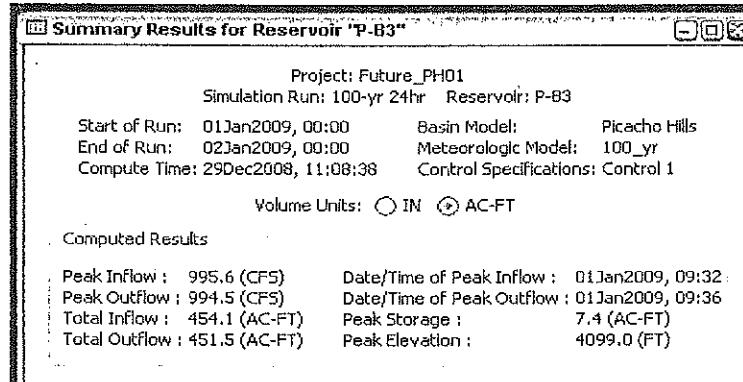
Pond B3

Total Storage Capacity	8.33 AC-FT
Dead Storage Capacity	2.19 AC-FT
Pond Top Elev.	4100 FT
Pond Invert Elev.	4082 FT
Principle Spillway	8-48" CMP Culverts
Culvert Inv. Elev.	4091 FT

Note: No flow overtop roadway.

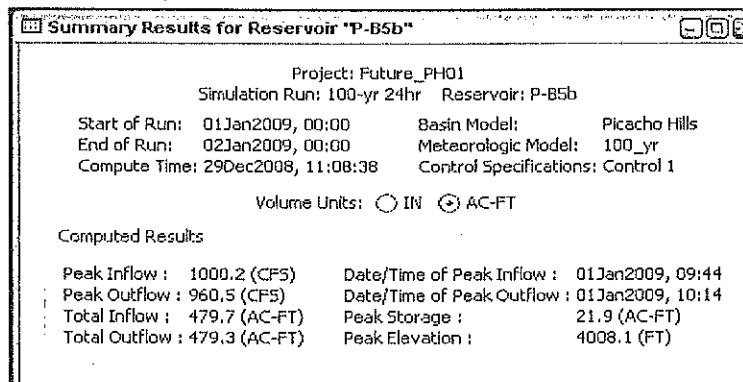
Pond B5b

Total Storage Capacity	28.28 AC-FT
Dead Storage Capacity	0 AC-FT
Pond Top Elev.	3966 FT
Pond Invert Elev.	3950 FT
Principle Spillway	8-48" CMP Culverts
Culvert Inv. Elev.	3950 FT

Note: No flow overtop pond embankment

A new ponding area is needed for the Barcelona Ridge Arroyo system. The goal of this pond is to attenuate the peak flow rate from the 100-yr storm event of storm water entering the Picacho Hills Diversion. The principle spillway and emergency spillway should be sized to convey the peak flow rate from the 100-yr storm event. The spillways would convey flow into the proposed Diversion system. **Figure 7: Proposed Improvements** provides the graphical location of the proposed pond. See **Table 9: Conceptual Pond Design** for additional information.

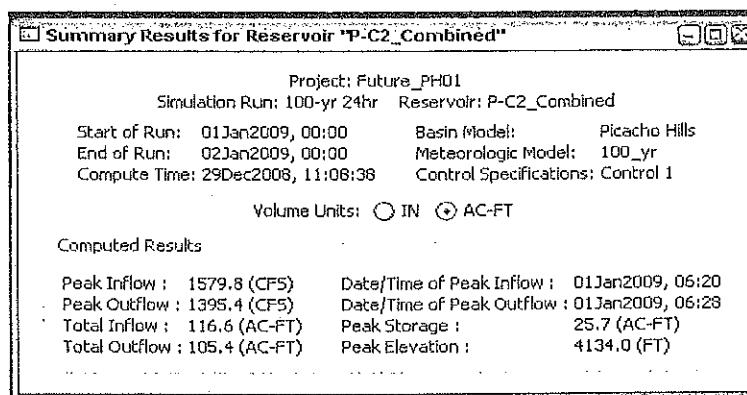
Pond C2

Total Storage Capacity	20.27 AC-FT
Dead Storage Capacity	10.77 AC-FT
Pond Top Elev.	4132 FT
Pond Invert Elev.	4100 FT
Principle Spillway	9-48" CMP Culverts
Culvert Inv. Elev.	4126 FT

Note: 2 FT flow overtop roadway.

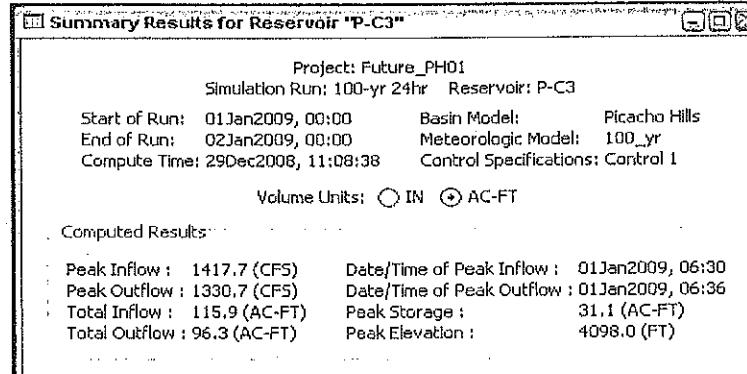
**Pond C3**

Total Storage Capacity	26.22 AC-FT
Dead Storage Capacity	18.85 AC-FT
Pond Top Elev.	4095.5 FT
Pond Invert Elev.	4056 FT
Principle Spillway	7-30" CMP Culverts
Culvert Inv. Elev.	4091 FT

Note: 2.5 FT flow overtop roadway.

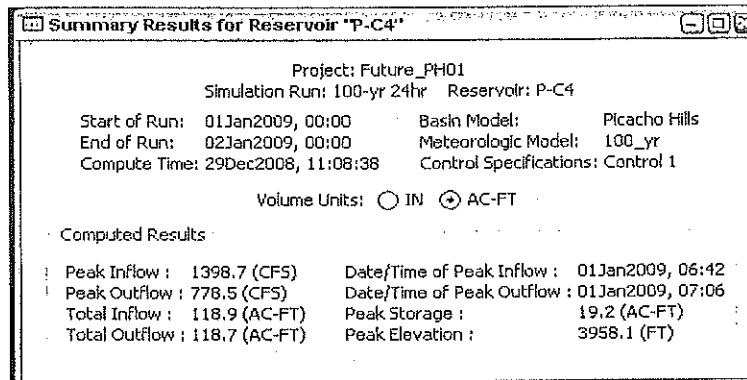
**Pond C4**

Total Storage Capacity	25.45 AC-FT
Dead Storage Capacity	0 AC-FT
Pond Top Elev.	3960 FT
Pond Invert Elev.	3944 FT
Principle Spillway	4-48" CMP Culverts
Culvert Inv. Elev.	3944 FT

Note: No flow overtop pond embankment

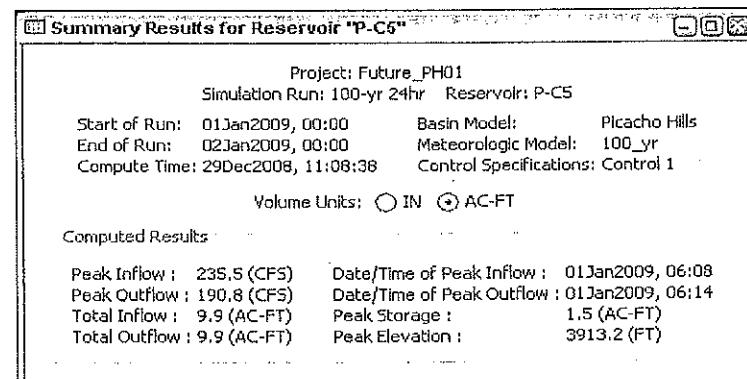
Total Storage Capacity	3.02 AC-FT
Dead Storage Capacity	0 AC-FT
Pond Top Elev.	3916 FT
Pond Invert Elev.	3908 FT
Principle Spillway	3-36" CMP Culverts
Culvert Inv. Elev.	3908 FT

Note: No flow overtop pond embankment

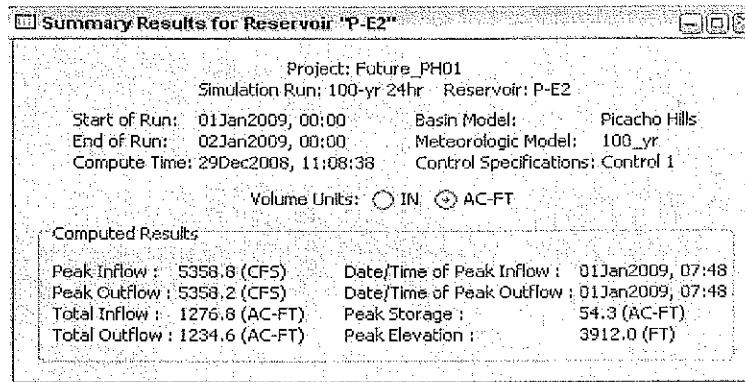
Pond E2 (Nafzinger Arroyo Pond)

Total Storage Capacity	54.47 AC-FT
Dead Storage Capacity	41.33 AC-FT
Pond Top Elev.	3912 FT
Pond Invert Elev.	3880 FT
Principle Spillway	10- 3FT (H) x 29FT (W) CBC
Culvert Inv. Elev.	3908 FT

Note: No flow overtop roadway.

Due to constraints within HEC-HMS, the number of culverts which can be modeled as a pond spillway is limited to 10 culverts. 48 CBCs each 3 FT (H) x 6 FT (W) will be utilized instead of the 10 culverts each, 3FT (H) x 29FT (W)

Goal: Analyze a constructible solution for the proposed Nafzinger Arroyo Pond principle spillway. HEC-HMS limits the number of culvert pipes that can be analyzed as an outfall to a pond, to 10. Using HEC-HMS for the future conditions model, 10 culverts, each 3' (H) x 29' (W) recommended. Verify that 48 culverts each, 3' (H) x 6' (W) will convey an equivalent flow.

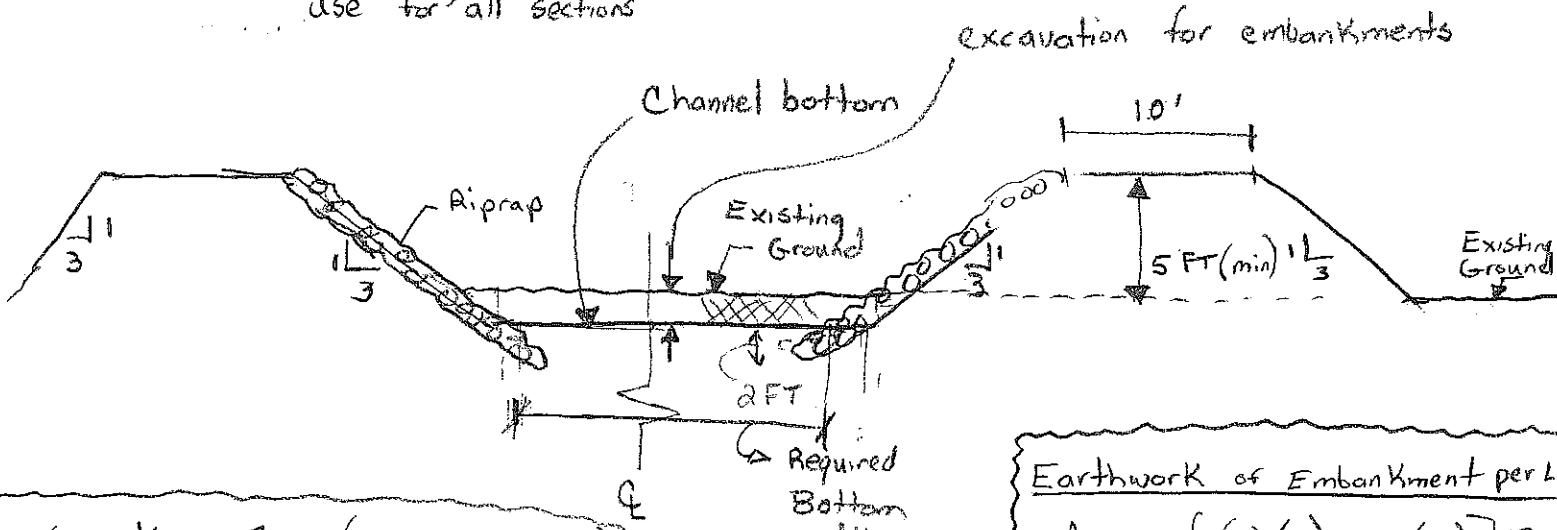
Picacho Hills Diversion System Earthwork

Embankment Quantity
use for all sections

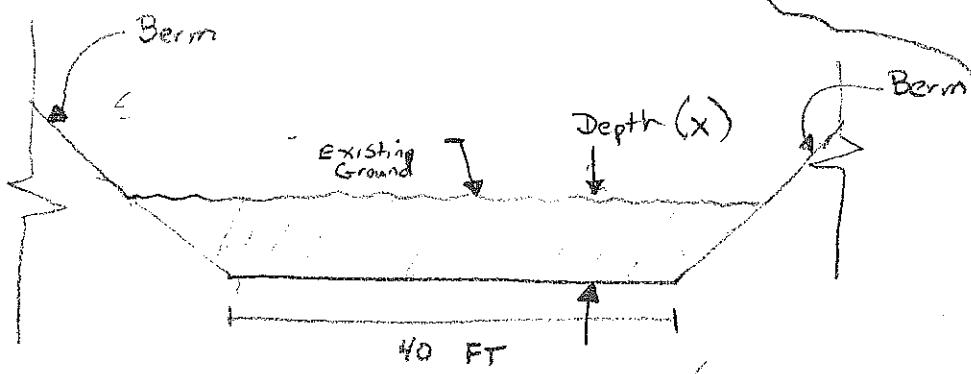
Section 1 (Basins C, D)

Earthwork of Embankment per LF

$$\text{Area} = [(10)(5) + 5(15)] \times 2 \\ = [125 \text{ SQ FT}] \times 2$$

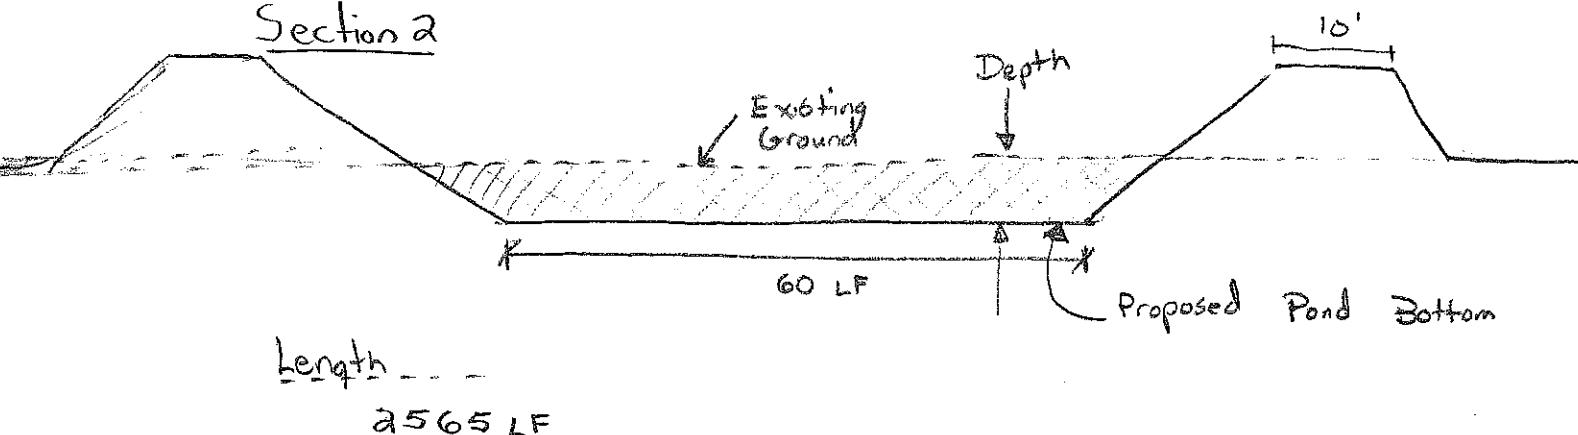
Section 2

$$(\text{Section 2 Area}) = (\text{Berm Area})$$

$$3(\text{Depth})(\text{Depth}) + (60)(\text{Depth}) = 185 \text{ Sq. ft}$$

$$\begin{aligned} V &= (185)(2565) \text{ ft}^3 \\ &= 17,580 \text{ cu. ft.} \end{aligned}$$

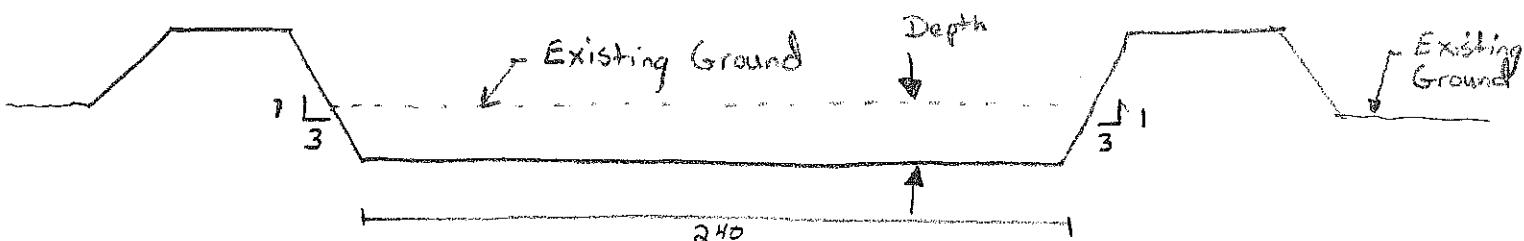
Section 3

$$3(\text{Depth})^2 + 240(\text{Depth}) = 185 \text{ sq. ft}$$

$$\text{Depth} = 0.76 \text{ FT}$$

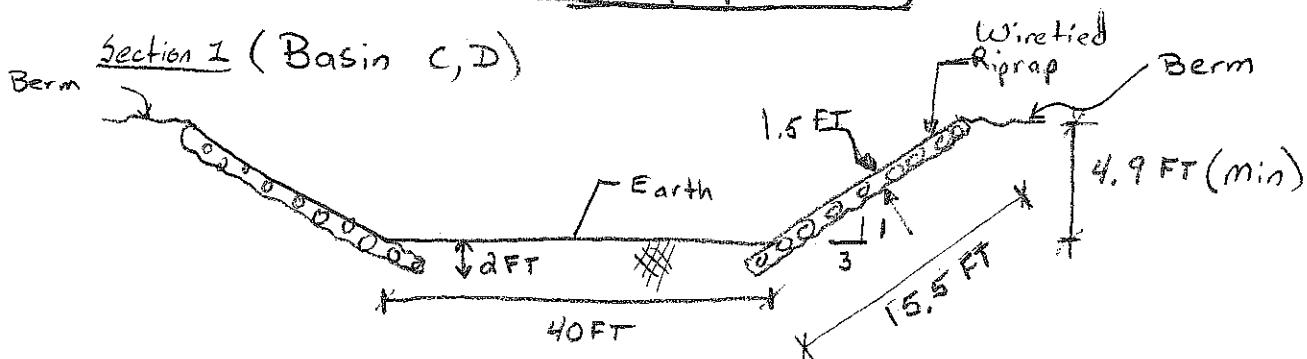
Section I (Basin C, D)

Picacho Hills Diversion System - Riprap Quantity

Length of section 1
2820 LF

Riprap Quantity per LF channel

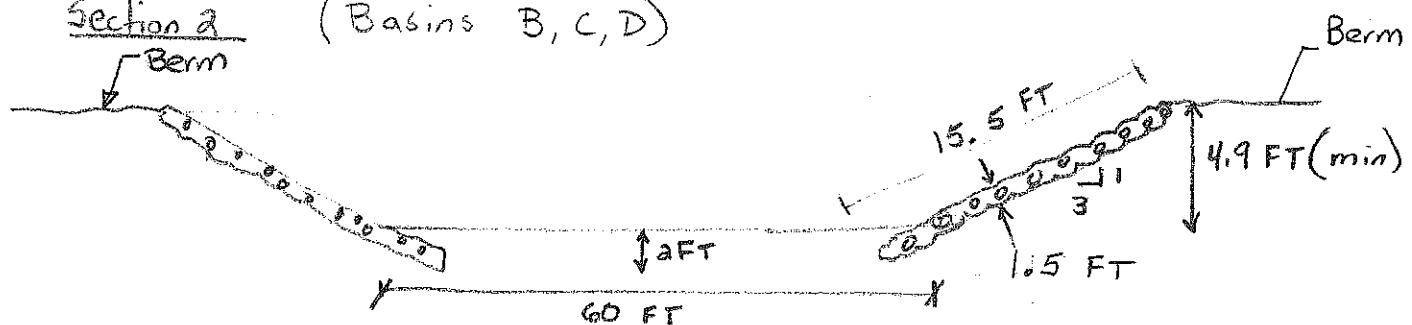
(Basins B, C, D)

Length Section 2

2565 LF

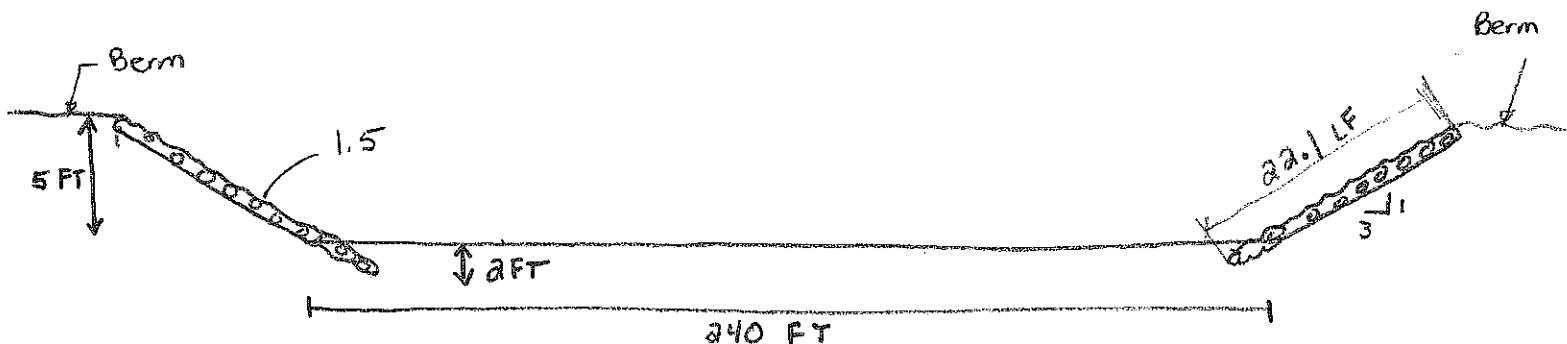
Section 3 (River Outfall, Basins A, B, C, D)

Length of Section 3

8645 LF

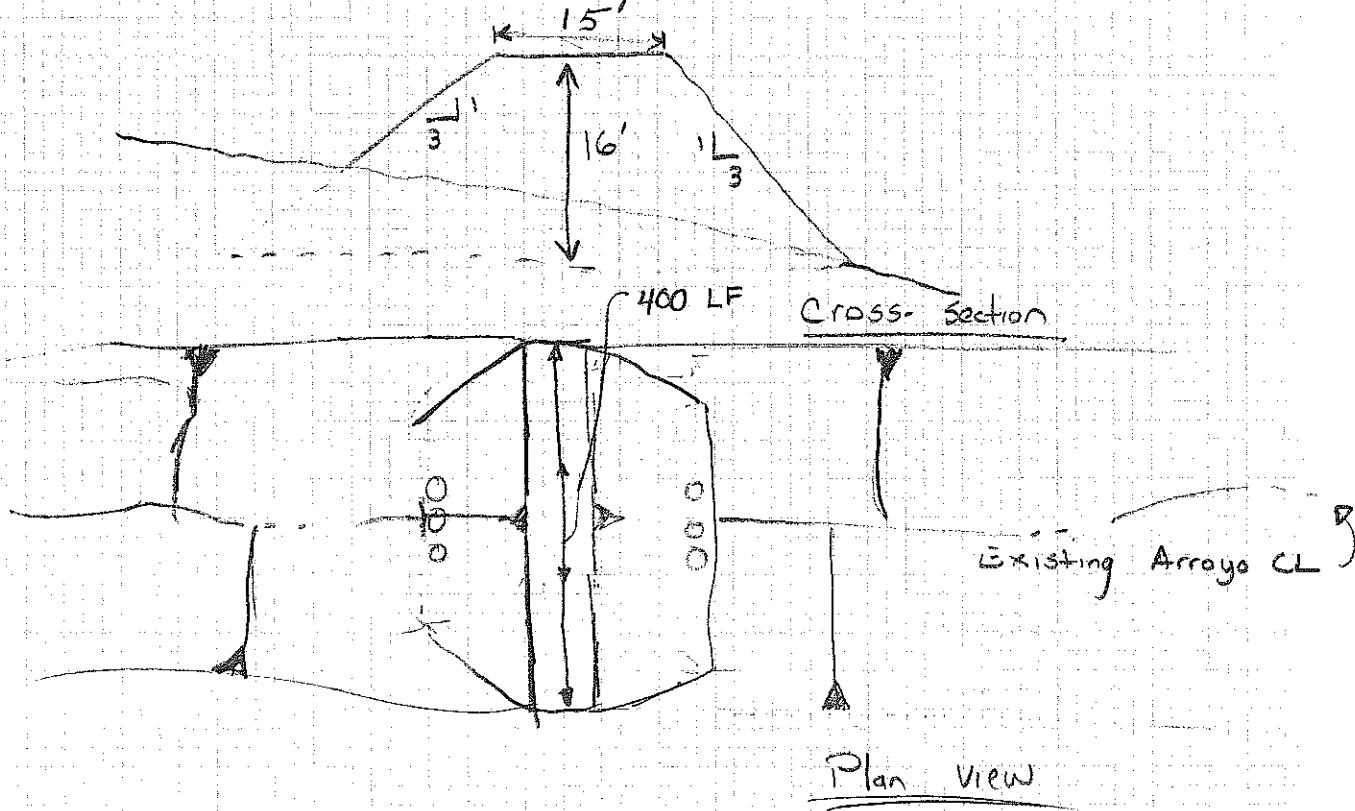
Barcelona Ridge Pond 56 (Pond B56)

Embankment ONLY. Requires no flood pool excavation.

Volume of Embankment

$$V = [3(16)(46) + (16)(15)] \cdot 400$$
