PICACHO HILLS DRAINAGE MASTER PLAN

MARCH 2009

Dona Ana County Flood Commission
845 N. Motel Boulevard
Las Cruces, NM 88001

Bohannan Huston, Inc.

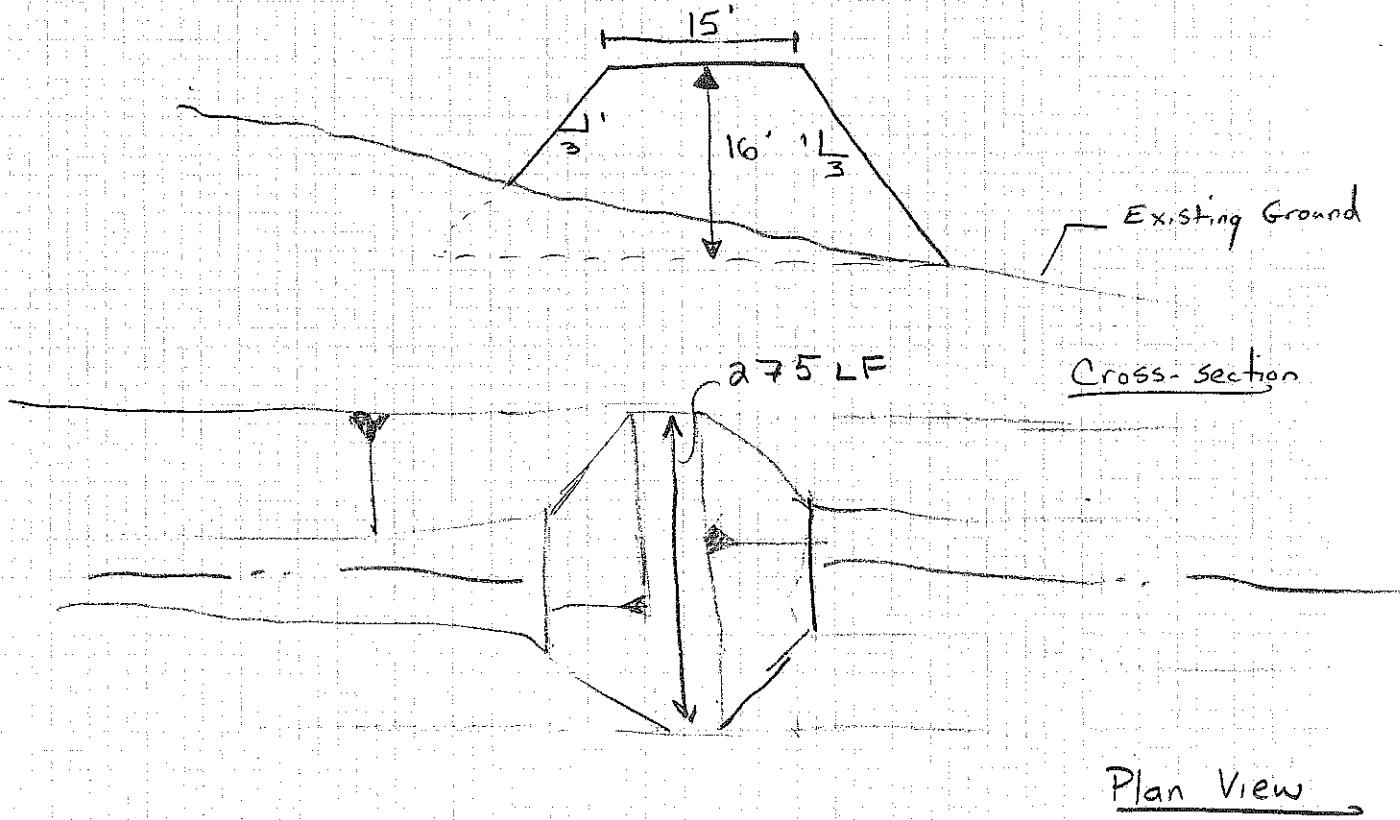
Plan View

Embankment ONLY. Requires no flood pool excavation

Volume of Embankment

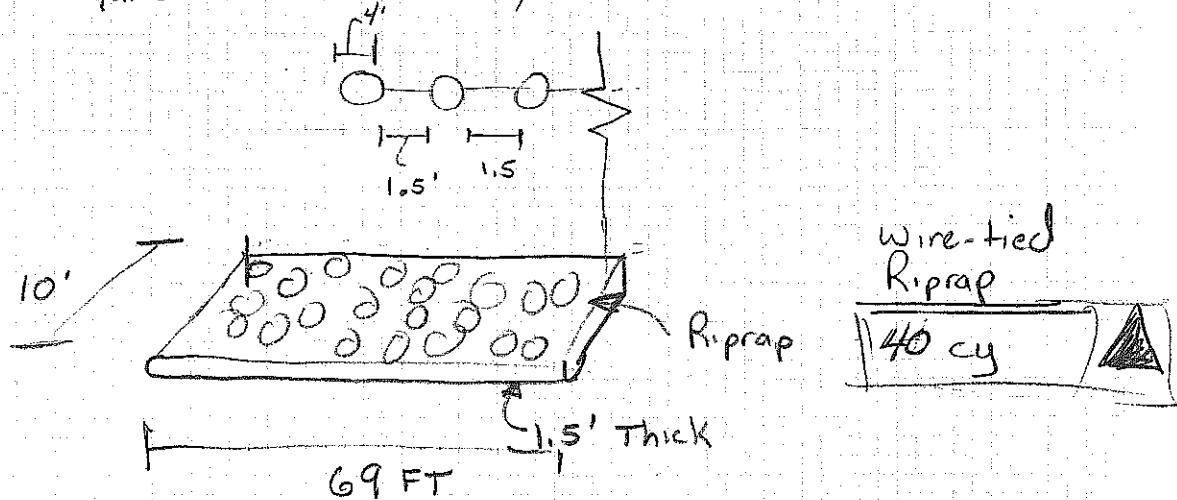
Barcelona Ridge Arroyo @
Picacho Hills Crossing

Requires 11 - 48" CMP,

- ▲ Requires 11 - 48" CMP culverts
↳ See attached culvert design calculation

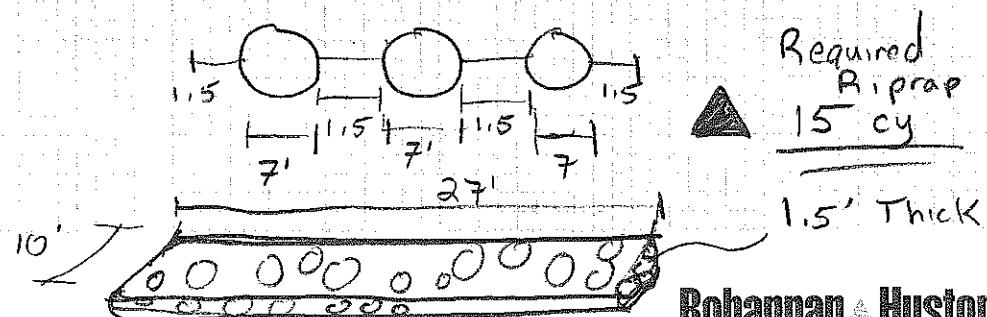
Golf Course Arroyo Crossing
@
Via Norte

Requires 3 - 84" CMP

Flow Rate	1394.0000 cfs
Control	Inlet
Capacity	1240.5645 cfs
Manning's Velocity	12.0741 ft/s
Headwater	10.3132 ft
Critical Depth	5.6500 ft
Normal Depth	7.0000 ft
Size (W x T):	84.00 x 0.1090

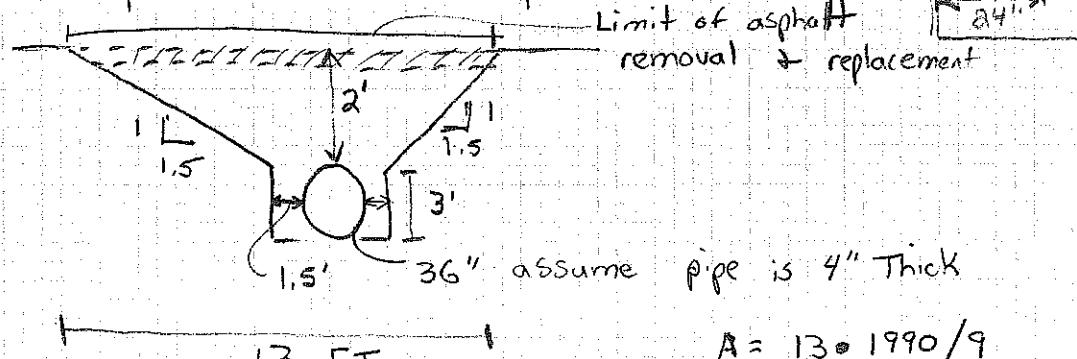
- No existing curb and gutter
- Install equivalent to NMDOT Concrete barrier curb, type B 6" x 24" tall pan both sides of entire street

- Asphalt Removal & Replacement

1.5' 2' 1.5' 3' 36" assume pipe is 4" Thick

13 FT

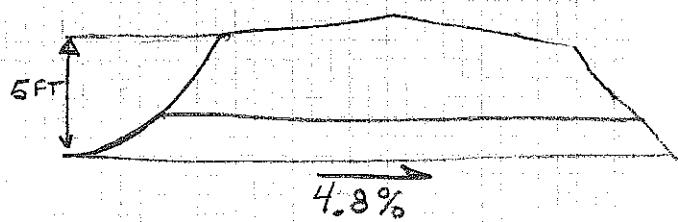
- Assume water is NOT allowed to cross overtop Picacho Hills Drive.
- See attached figure denoting proposed culvert crossing location
- Slope = $\frac{3978 - 3972}{125} = 0.048 \frac{\text{ft}}{\text{ft}}$
- Max headwater Depth : 5 FT
- Max culvert Dia. allowable : 48"

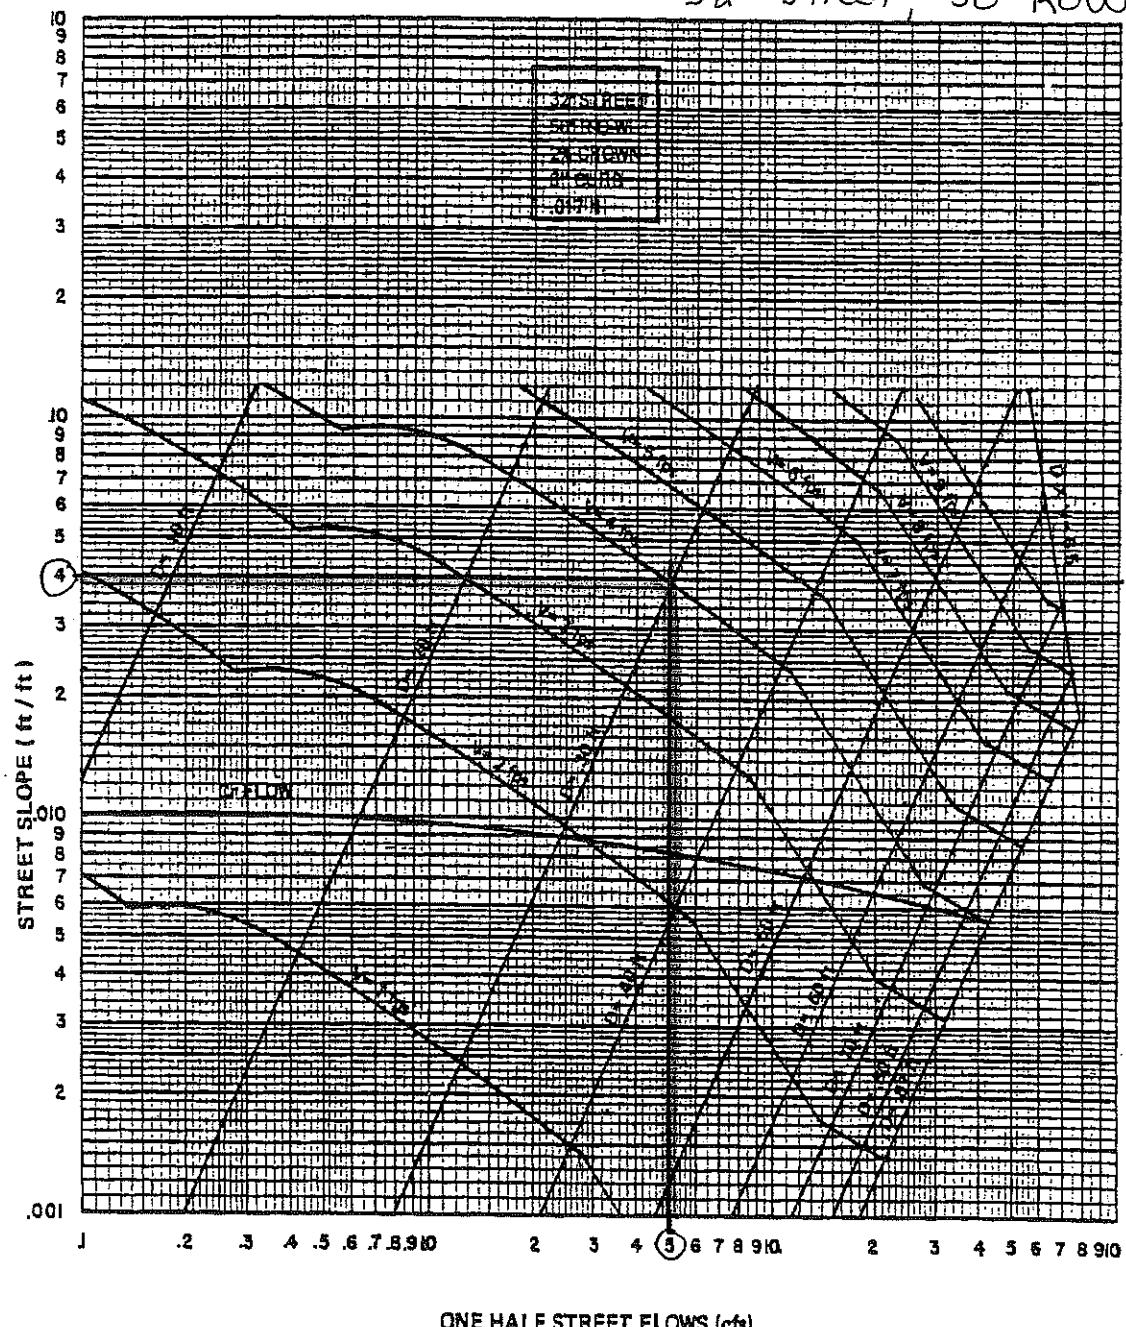
STREET CAPACITY

32' Street, 50' ROW, 2% Crown
6" Curb

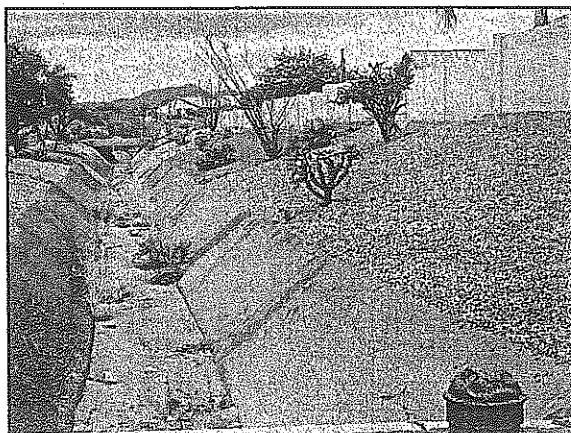
- Provide 6 inch curbs at all streets
- Eliminate sand, silting and sediment in residential streets apply drop down storm drains into precast
- Landscape open areas

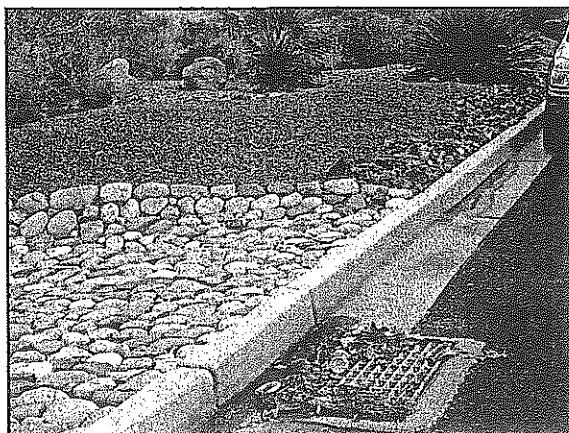
- Adopt off road sump design used in Arizona
- They handle larger theoretical capacity with more available area at 70% minimum
- They may be used at existing road swales

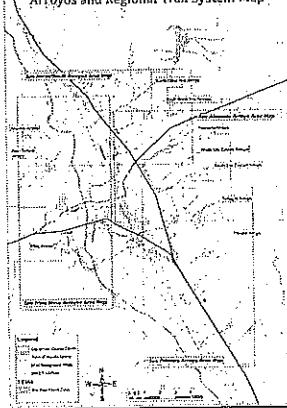
ARROYO DESIGNATION

MAJOR ARROYO

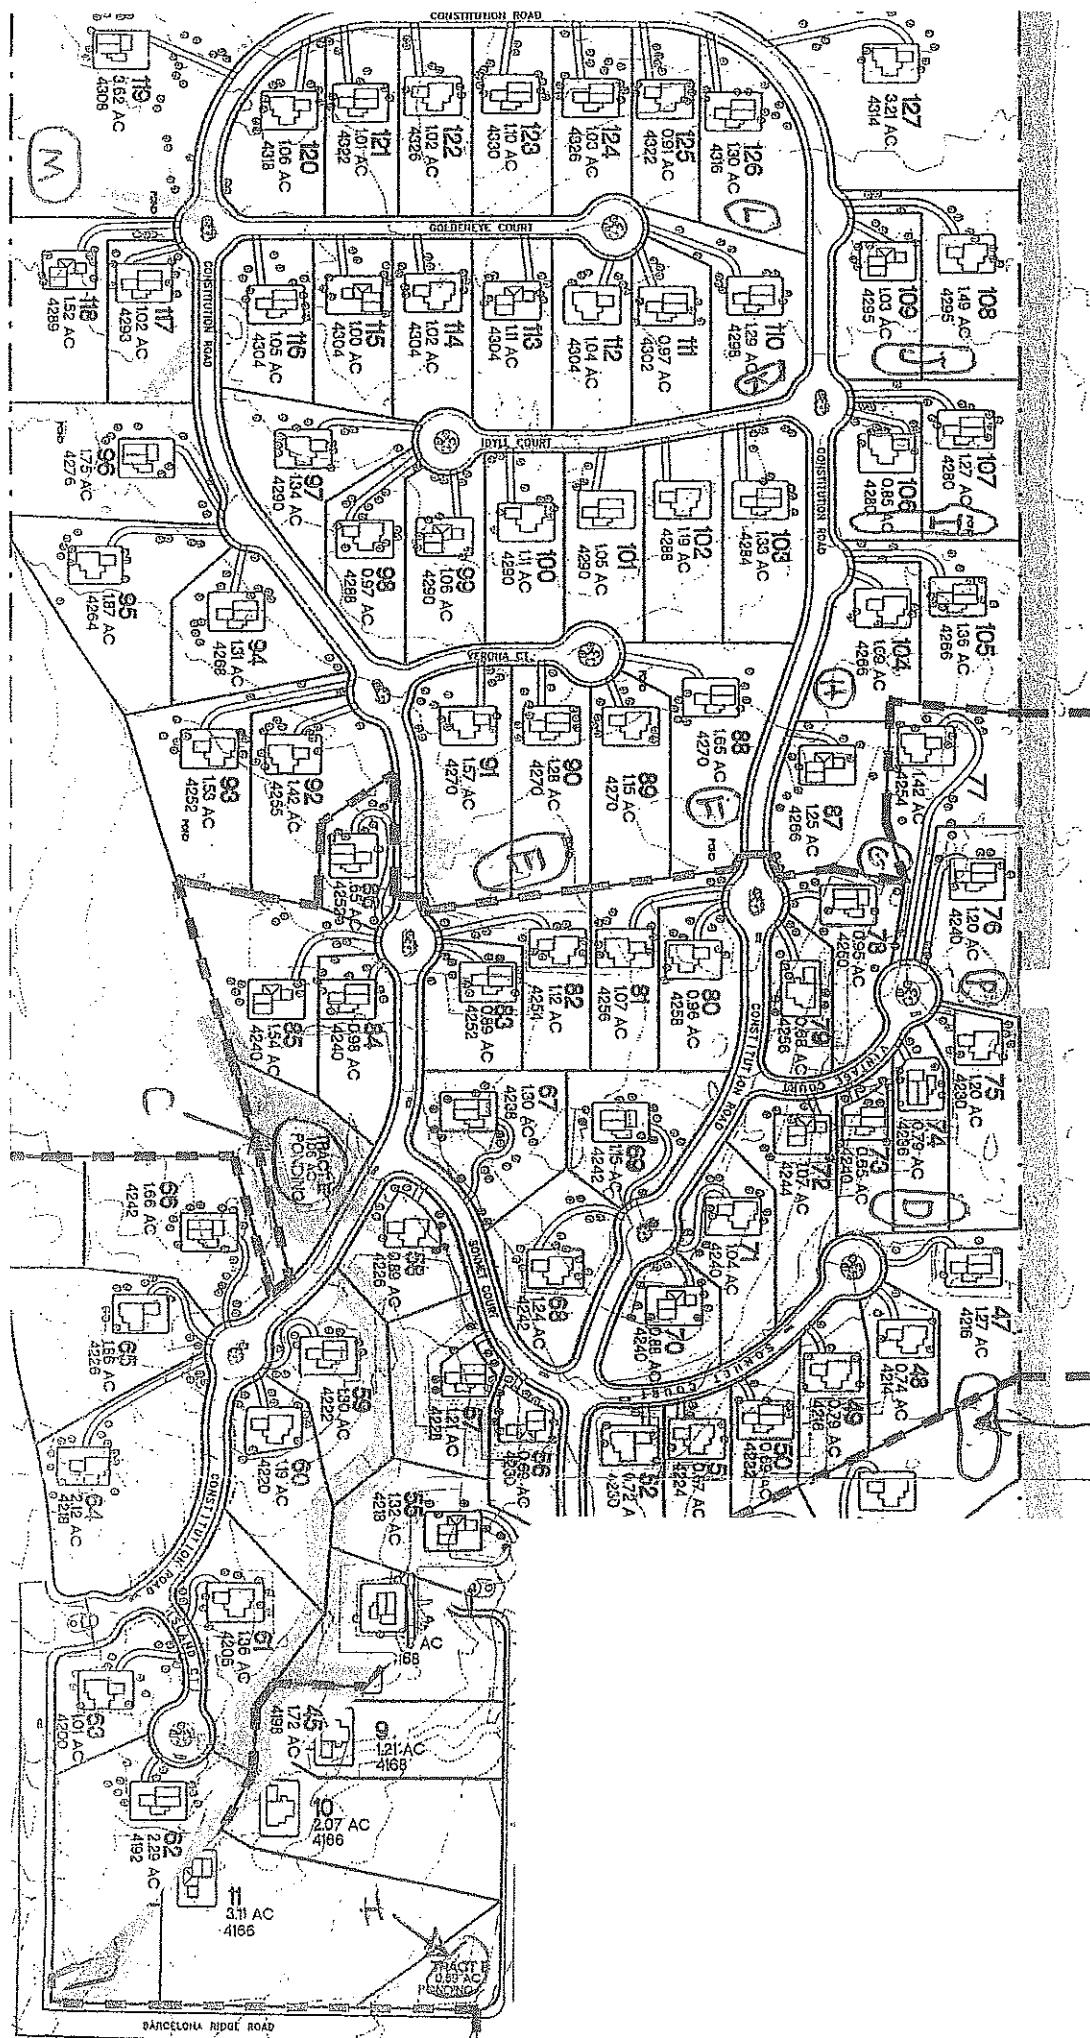
CORONADO RIDGE EROSION/DRAINAGE ISSUES

PINK – Arroyo stabilization and restoration

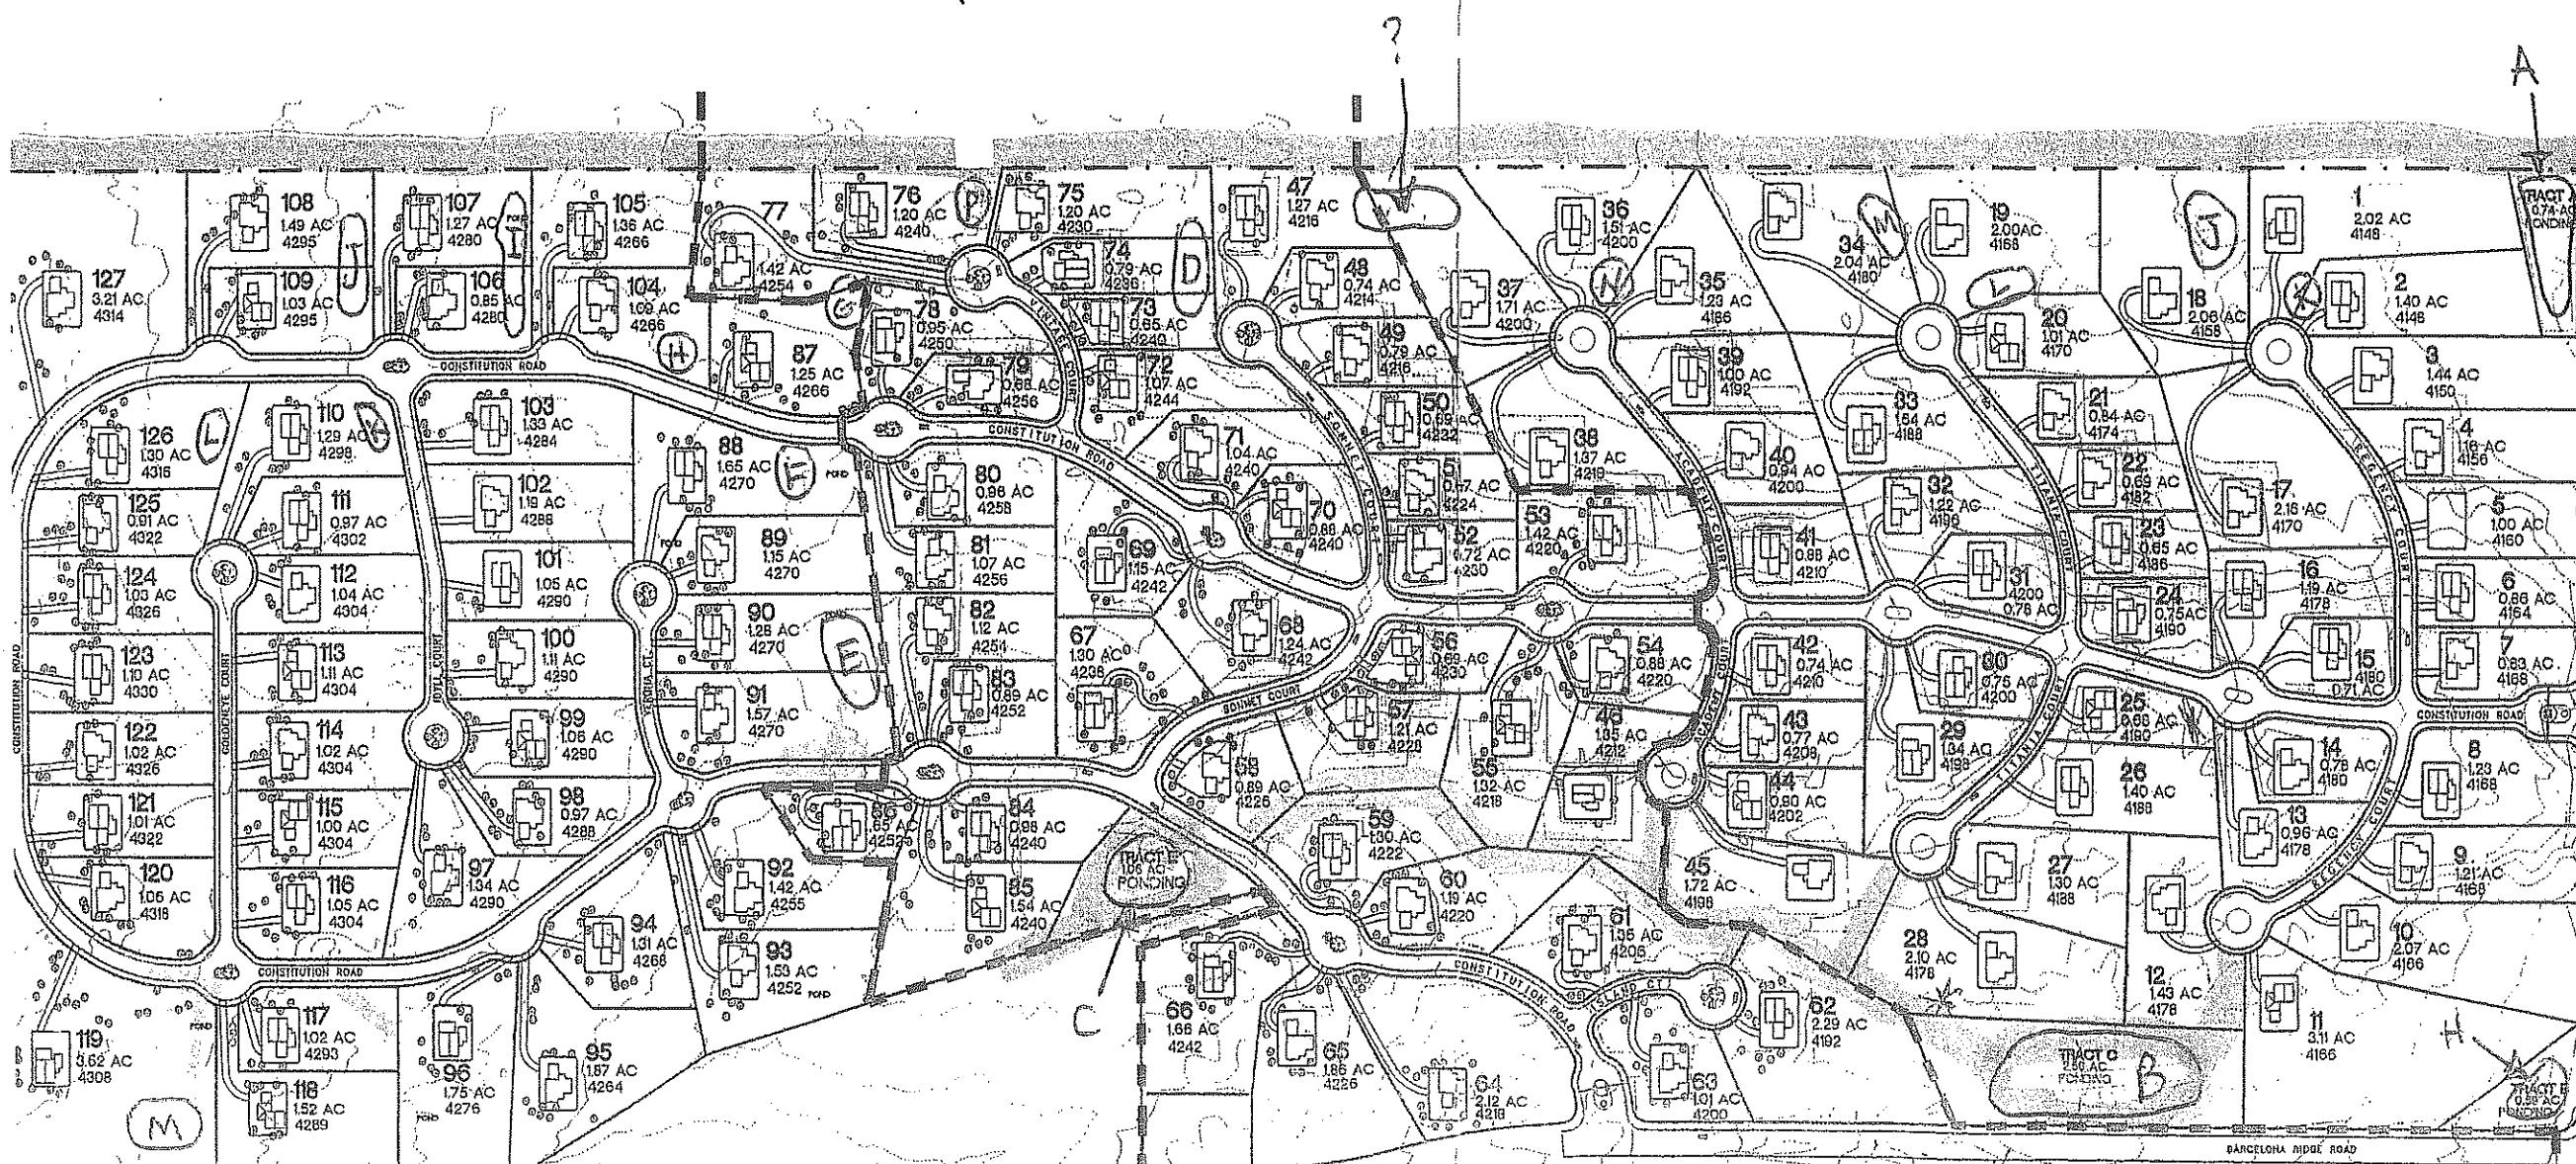
CORONADO RIDGE EROSION/DRAINAGE ISSUES

PINK – Arroyo stabilization and restoration
