**FIRST FIVE-YEAR REVIEW REPORT FOR  
GRIGGS AND WALNUT GROUND WATER PLUME SUPERFUND SITE  
LAS CRUCES, DOÑA ANA COUNTY, NEW MEXICO**

**SEPTEMBER 2016**

**U.S. Environmental Protection Agency  
Region 6  
Dallas, Texas**

**FIRST FIVE-YEAR REVIEW REPORT**  
**GRIGGS AND WALNUT GROUND WATER PLUME SUPERFUND SITE**  
**EPA ID#: NMD0002271286**  
**DOÑA ANA COUNTY, NEW MEXICO**

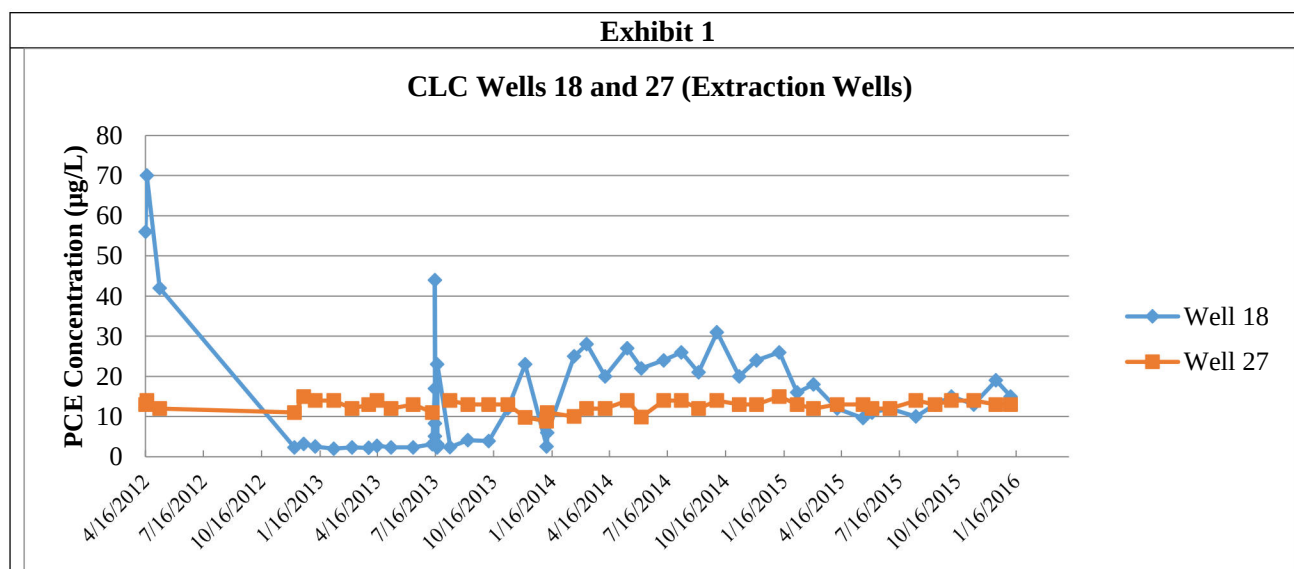
A time-series plot of PCE concentrations versus time was prepared for CLC Wells 18 and 27 (Exhibit 1).

PCE concentrations in CLC Well 18 were initially as high as 70 µg/L (when system operations began in April 2012), and rapidly decreased (ranging from approximately 2 to 3 µg/L) in December 2012 through July 2013.

An assessment of the well hydraulics revealed that this well yields water from both the screened interval (315 to 516 ft. bgs) and the saturated gravel pack in the annulus above the well screen. Ground water with lower PCE concentrations in the deeper aquifer (Layer 3) had effectively diluted the higher concentrations of PCE that were initially extracted from the shallow aquifer (Layer 1).

PCE concentrations in CLC Well 27 have been consistent (ranging from approximately 9 µg/L to 15 µg/L) over time. An optimization test was conducted between November 2013 and January 2014, where the pumping rate was increased from 130 gpm to 170 gpm (by 20 gpm increments in 30-day intervals). PCE concentrations remained stable (between 9.8 µg/L and 13 µg/L), indicating that increasing the pumping rate increases the PCE mass removal with a greater volume of water being treated.

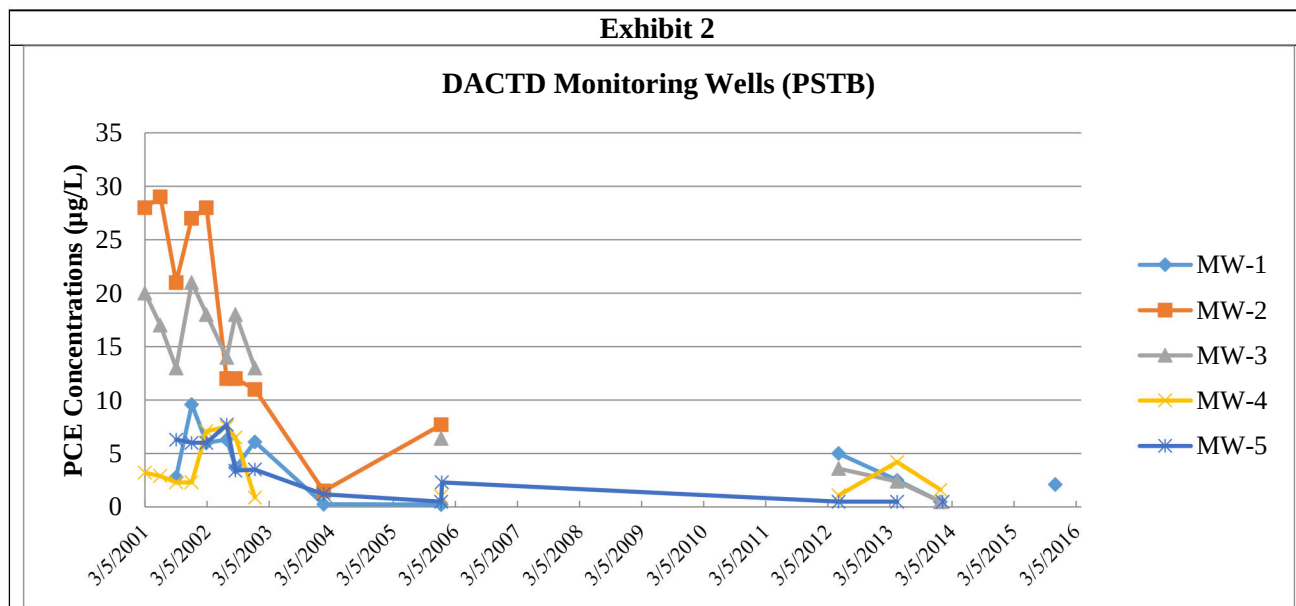
A time-series plot of PCE concentrations versus time was prepared for monitoring wells installed by the NMED Petroleum Storage Tank Bureau (PSTB) as part of the release response for petroleum contamination at the DACTD site (Exhibit 2).

Decreasing PCE concentrations in the shallow aquifer (Layer 1) may be attributed to petroleum contaminant removal actions at the DACTD site and possibly the influence of pumping ground water from CLC Well 18 to maintain hydraulic control of the PCE plume from 2005 to 2008. PCE concentrations in these wells have remained below the MCL (5 µg/L) since the start of remedial system O&M in April 2012.

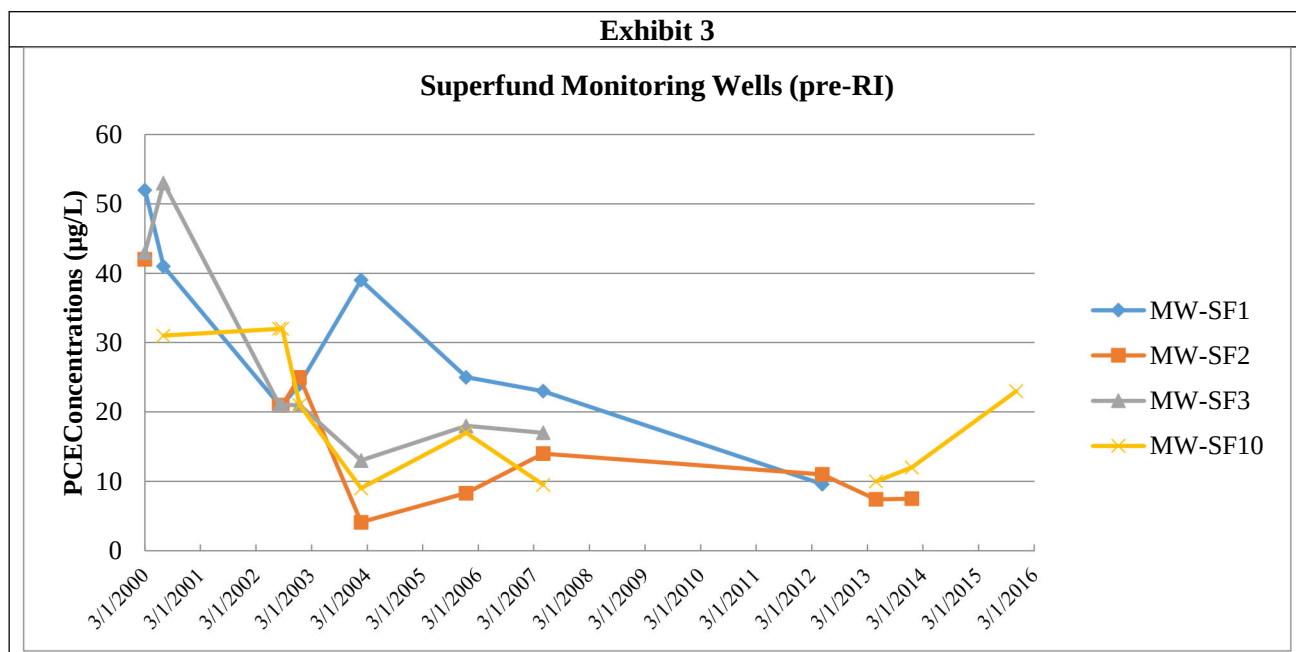
A time-series plot of PCE concentrations versus time was prepared for single-stage monitoring wells (located near CLC Well 18) installed in 2000 by the NMED-SOS to determine the extent of PCE contamination at the Site (Exhibit 3).

Decreasing PCE concentrations in the shallow aquifer (Layer 1) since March 2000 (when these wells were installed) are likely attributed to the influence of pumping ground water from CLC Well 18 to maintain hydraulic control of the PCE plume from 2005 through 2008. However, PCE concentrations have increased in monitoring well MW-SF10, which is located downgradient and outside of the radius of influence for the extraction well.

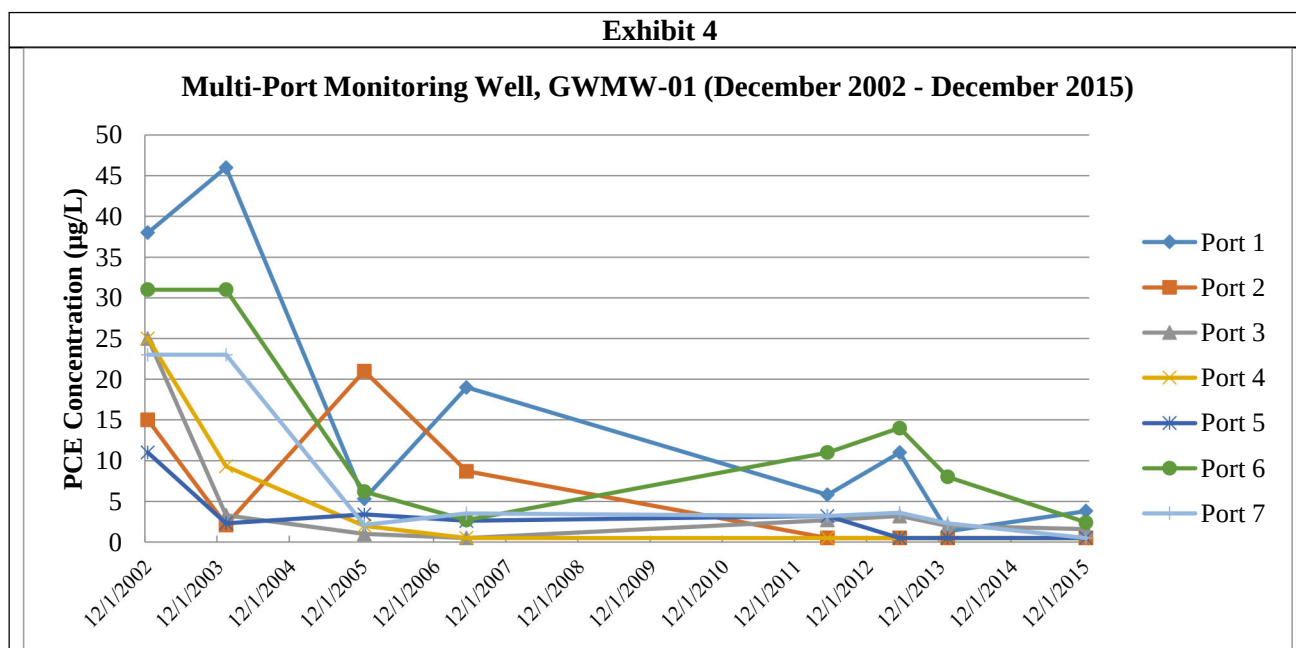
A time-series plot of PCE concentrations versus time was prepared for multi-port monitoring well GWMW-01 (located near CLC Well 18) installed by the EPA as part of the RI activities at the Site. Well GWMW-01 contains seven ports (Ports 1 through 7) from shallow to deep (Exhibit 4).

Decreasing PCE concentrations in the shallow, intermediate, and deep aquifers (Layers 1, 2, and 3) from 2002 through 2008 are likely attributed to the influence of pumping ground water from CLC Well 18 to maintain hydraulic control of the PCE plume from 2005 through 2008. Decreasing PCE concentrations from 2012 through 2015 are likely attributed to ground water extraction at CLC Well 18 (Figure 8 and 9) and improved PCE extraction rates associated with remedial system O&M since April 2012 (Exhibit 5).

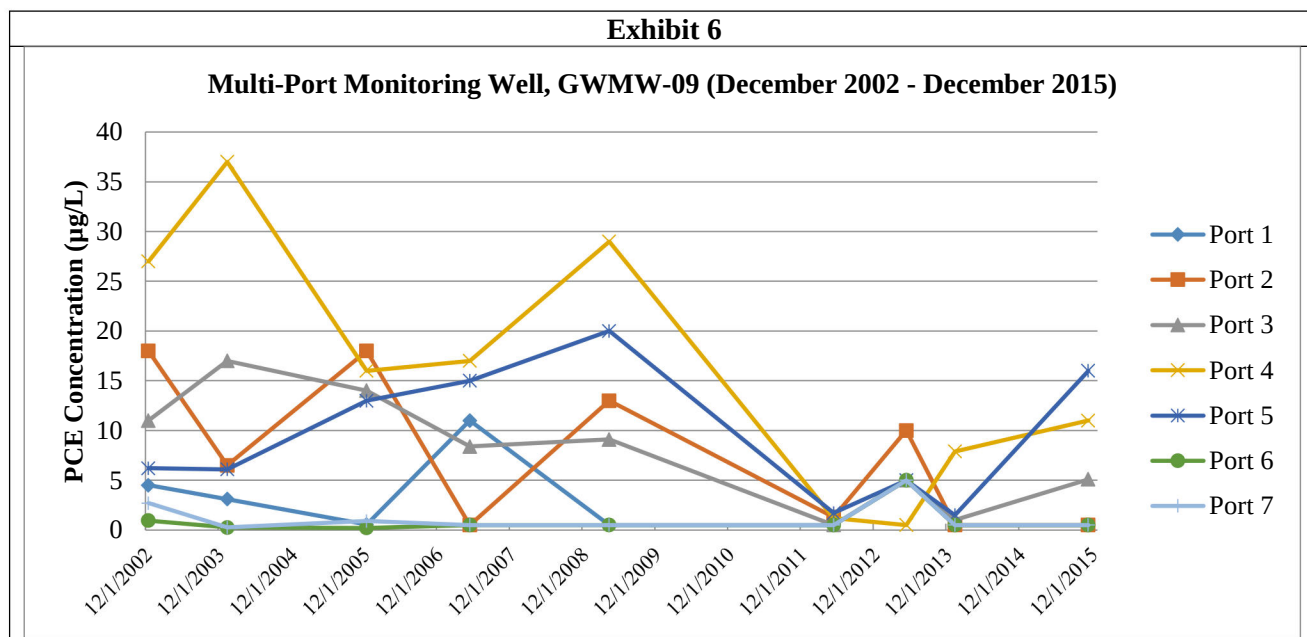
A time-series plot of PCE concentrations versus time was prepared for multi-port monitoring well, GWMW-09 (located downgradient of CLC Wells 18 and 27) installed by the EPA as part of the RI activities at the Site (Exhibit 6).

PCE concentrations in samples collected from Ports 1 through 5 at multi-port monitoring well GWMW-09 exhibit considerable variability and lack any clear trends. PCE concentrations in samples collected in 2012 and earlier, range from the detection limit (0.5 µg/L) to 37 µg/L.

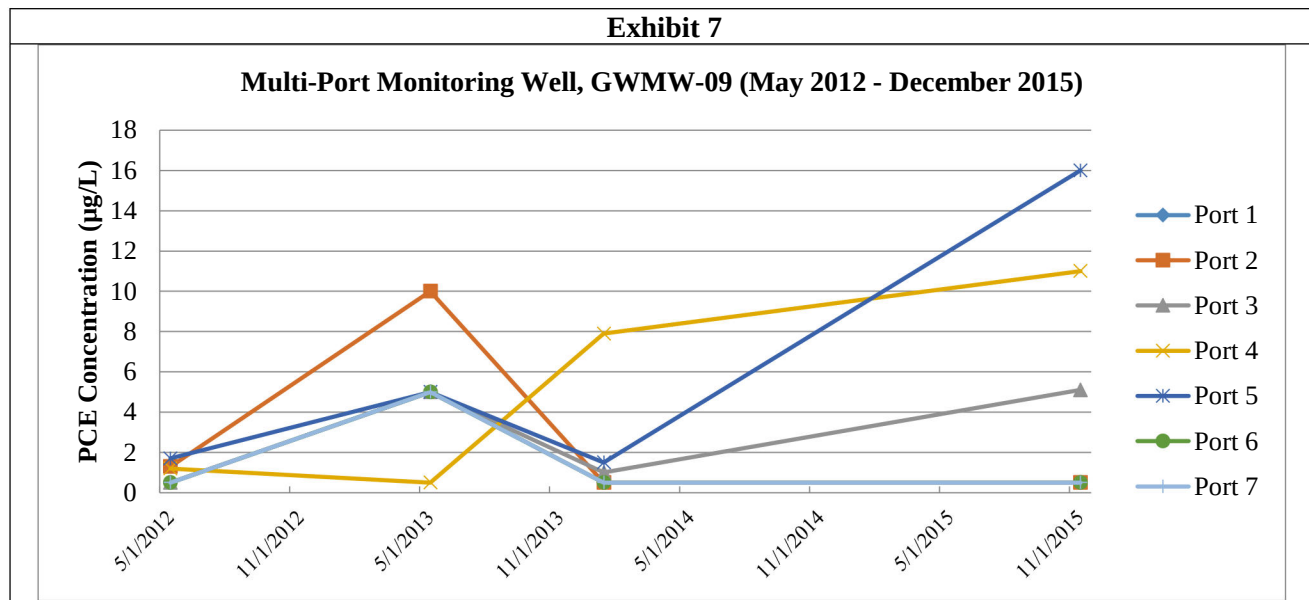
PCE concentrations in samples collected after 2012 from multi-port monitoring well GWMW-09 also exhibit considerable variability, and range from the detection limit (0.5 µg/L) to 16 µg/L (Exhibit 7).

Variability in the PCE concentrations in samples collected from Ports 1 through 5 in monitoring well GWMW-09 may be attributed to the differences in the sampling protocol used versus the guidelines recommended by the multi-port well manufacturer, as discussed under the Site Inspection observations below.

| Issues and Recommendations Identified in the Five-Year Review: | | | | |
|---|---|---|---|---|
| | <b>Recommendation:</b> The following steps should be taken to ensure that the sampling protocol implemented for the multi-port monitoring wells follows the manufacturer's " <i>Sampling guidelines for Water FLUTe systems installed <u>prior</u> to May, 2009</i> ", Revised April, 2010: <ol style="list-style-type: none"> <li>1. Verification of use of correct sampling protocol by field sampling personnel as provided by manufacturer's recommended guidelines and update Sampling and Analysis Plan to include the guidelines;</li> <li>2. Consultation and training of field sampling personnel as needed by manufacturer to ensure sampling protocol is implemented correctly;</li> <li>3. Implementation of sampling protocol in accordance with manufacturer's guidelines for all future sampling events; and</li> <li>4. Documentation of sampling procedures performed by field sampling personnel in field log book for all sampling events and provision of a copy of the signed and dated log book notes for each sampling event to EPA as an attachment to the annual remedial action progress reports or other such annual reports prepared and submitted to EPA as part of O&amp;M activities.</li> </ol> | | | |

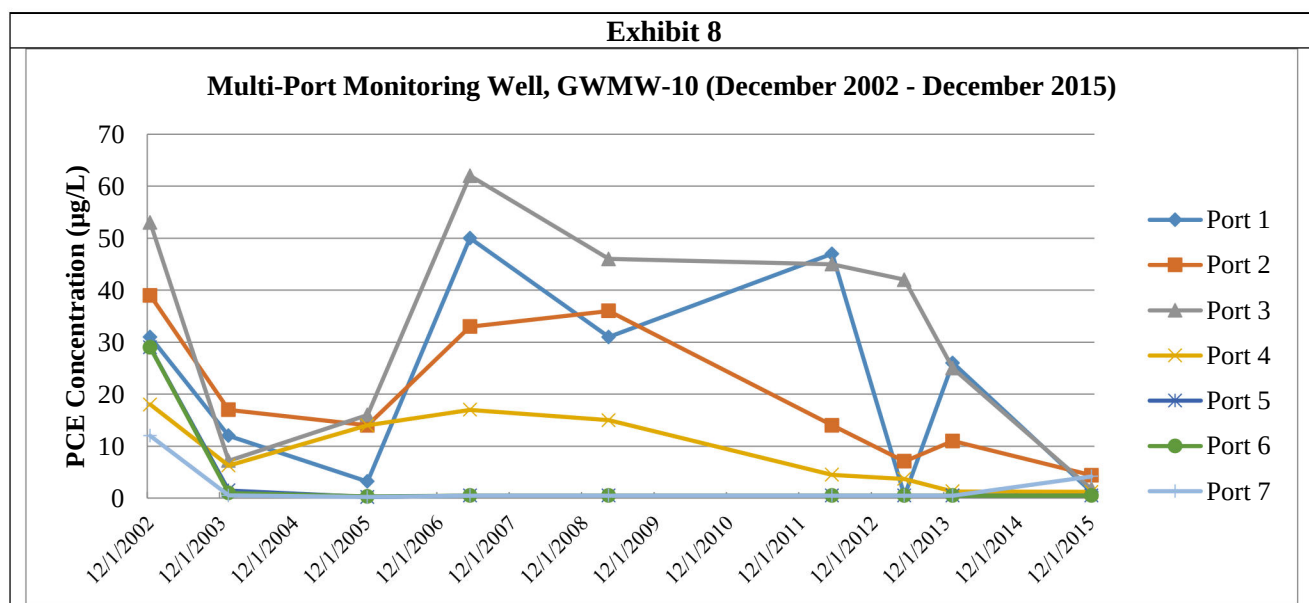
A time-series plot of PCE concentrations versus time was prepared for multi-port monitoring well GWMW-10 (located downgradient of CLC Wells 18 and 27), installed by the EPA as part of the RI activities at the Site (Exhibit 8 and Exhibit 9).

The significant increase in PCE concentrations in samples collected from multi-port monitoring well GWMW-10 since 2005 may be attributed to the absence of a confining layer separating the UHZ and LHZ, which allows for vertical downward ground water flow induced by pumping at CLC Well 27, as indicated by the interpreted radius of influence around this well, based on the 2015 water-level elevation data.

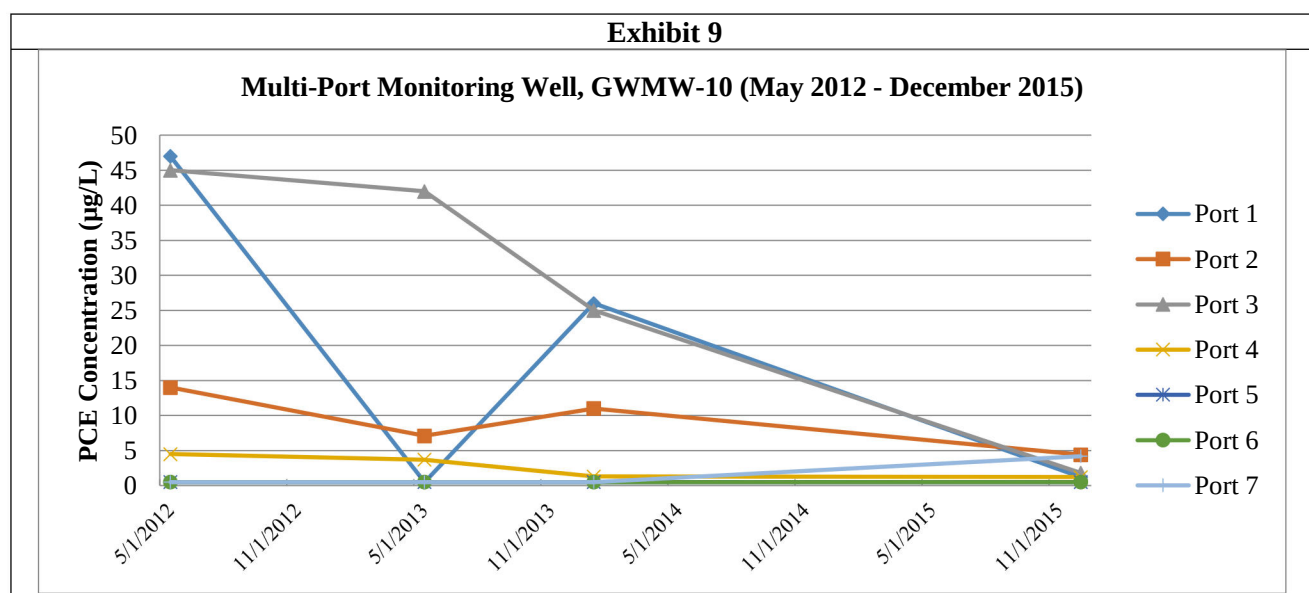
Similar variability in the PCE concentrations in samples collected from Port 1 in this monitoring well may be attributed to issues with the sampling process (as discussed for multi-port monitoring well GWMW-09 above), in particular for the samples collected in May 2013 and December 2015 (Exhibit 9).

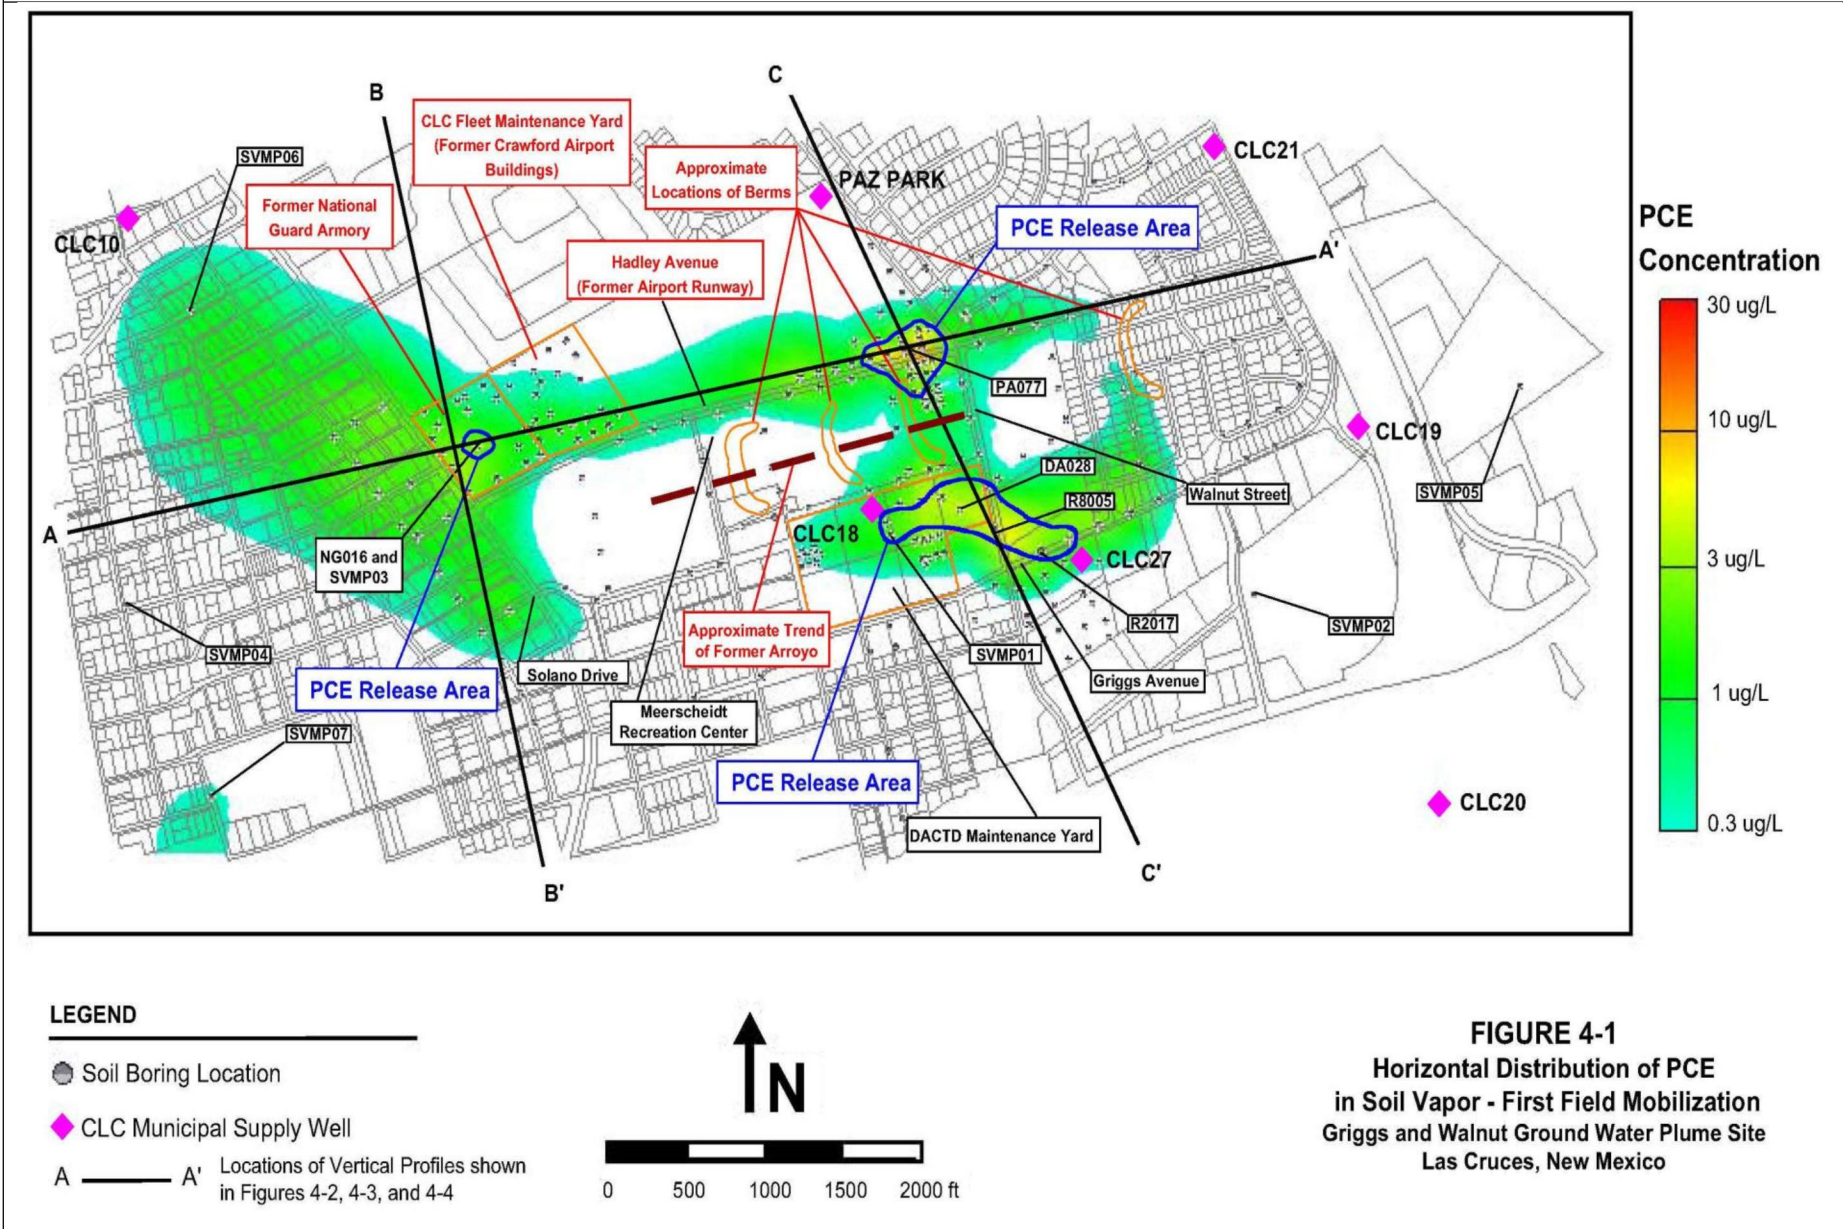
Figure 2 – PCE Release Areas

Based on data collected during the RI, three sources of PCE contamination were identified at the Site. Based on the soil vapor survey results, elevated concentrations of PCE were found at the former location of the Crawford Municipal Airport, at the present location of the Doña Ana County Transportation Department (DACTD) maintenance facility, and near the former location of a National Guard Armory (Appendix B, Figure 2).

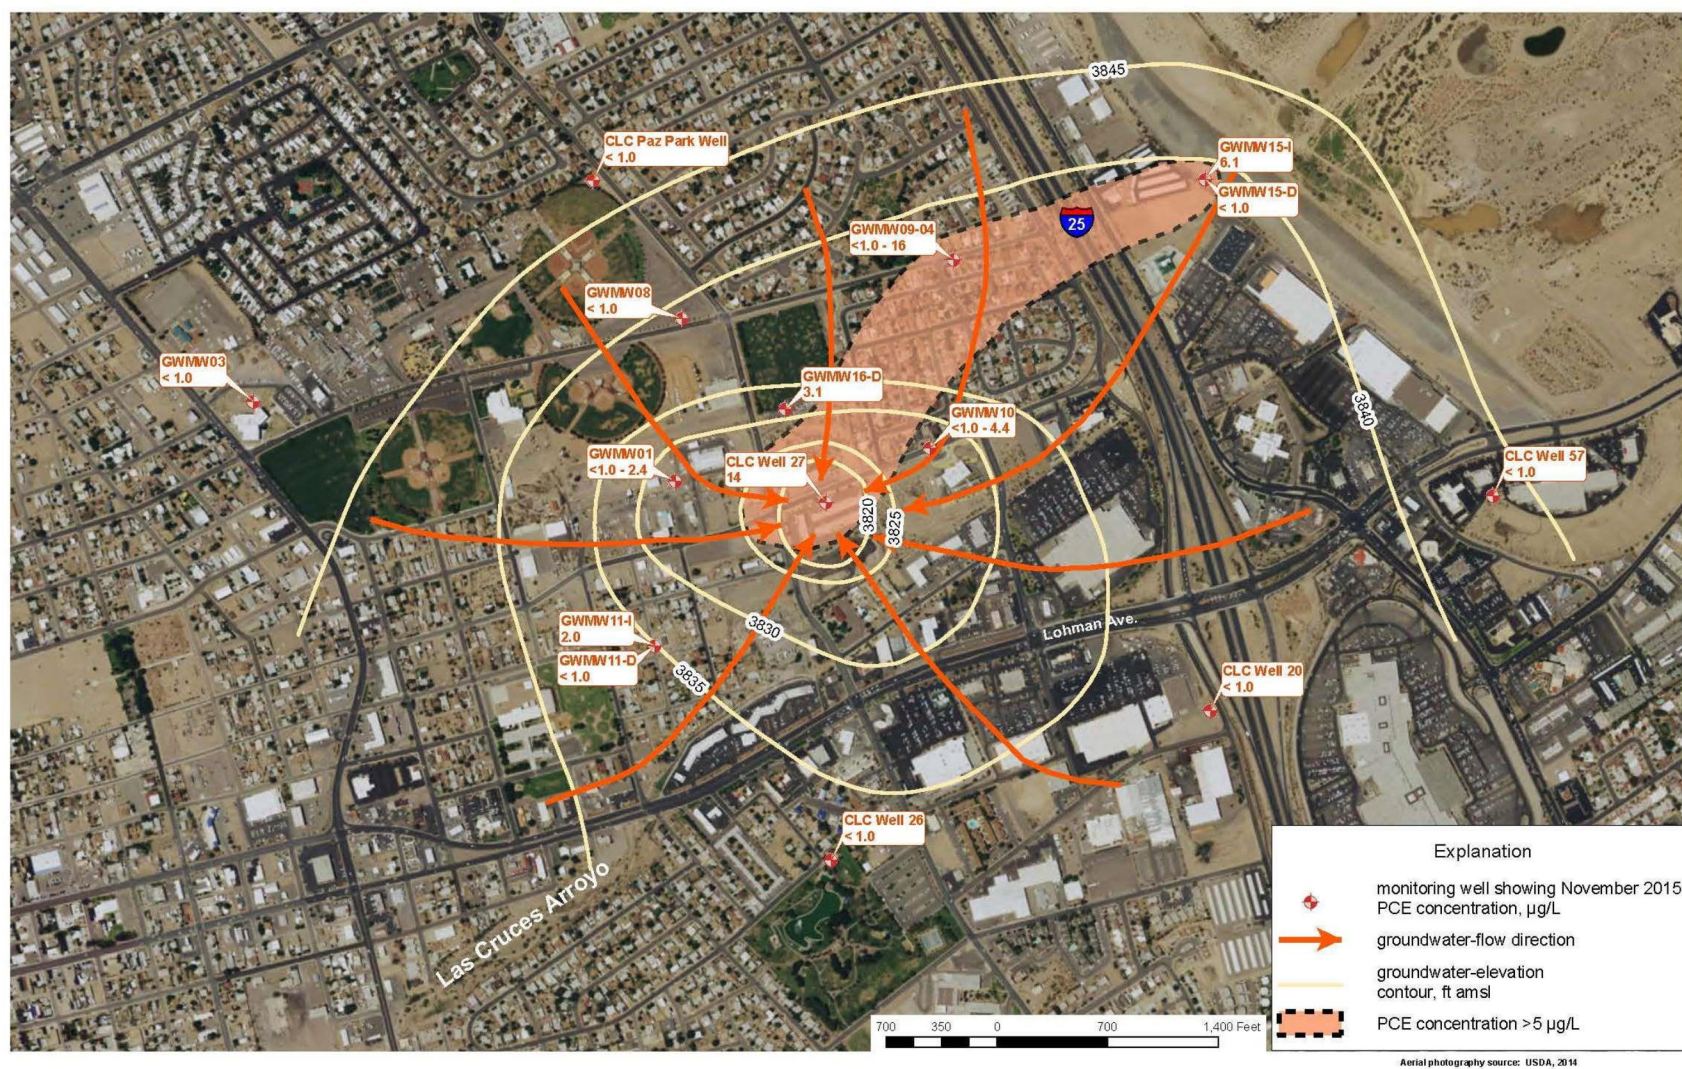
**Figure 10 – Ground Water Elevation Contours for the Lower Hydrogeologic Zone and PCE Plume  
November 2015 (JSAI, 2016)**

For the LHZ, JSAI has interpreted a much larger cone of depression centered on CLC Well 27, which is pumped continuously (Figures 10 and 11). The entire PCE plume in the LHZ is located within or near this cone of depression and appears to be hydraulically captured by pumping. However, it is noted that on Figure 11, the water level measured at GWMW16-D (approximately 3,842 ft. amsl) does not correlate to the water level contours drawn on the map, which suggests that the water level at GWMW16-D is approximately 3,832 ft. amsl. Honoring this value in the contouring effort for water elevations would change the map significantly. Yet, as stated above, this well has not been surveyed for top-of-casing elevation, and the 3,842 ft. amsl water level is only an estimate.

Figure 9. Aerial photograph showing November 2015 PCE concentrations and groundwater-elevation contours for the Lower Hydrogeologic Zone, Griggs and Walnut site, City of Las Cruces, New Mexico.

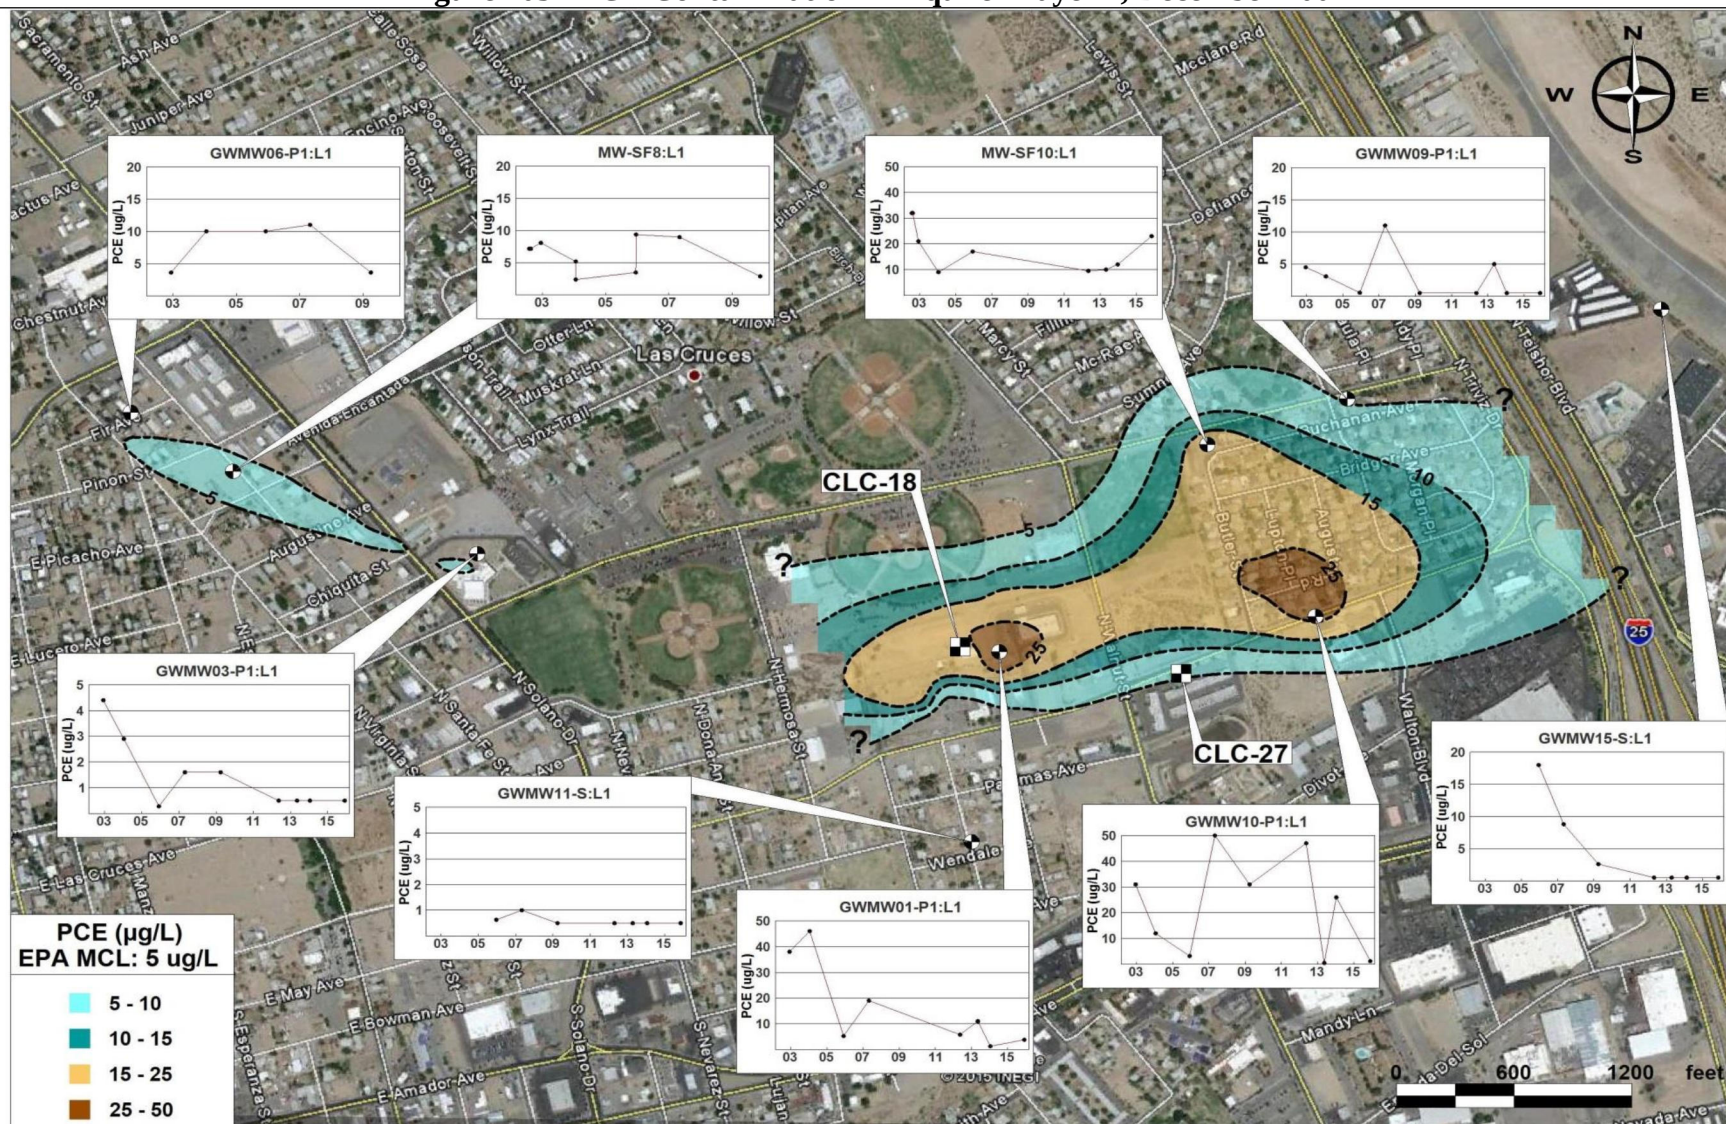
Figure 105 - PCE Contamination in Aquifer Layer 1, December 2002

For the FYR, NMED-SOS developed iso-concentration contour maps for PCE contamination in the shallow aquifer (Layer 1) in December 2002 (Figure 105), May 2007 (Figure 11), and May 2012 (Figure 127), along with time-series plots for specific wells that depict the historical trends for PCE concentrations across the Site.

PCE Isoconcentration Contour Map (December 2002)  
and Time Series Plots (2002-2016)  
Shallow Aquifer (Layer 1)

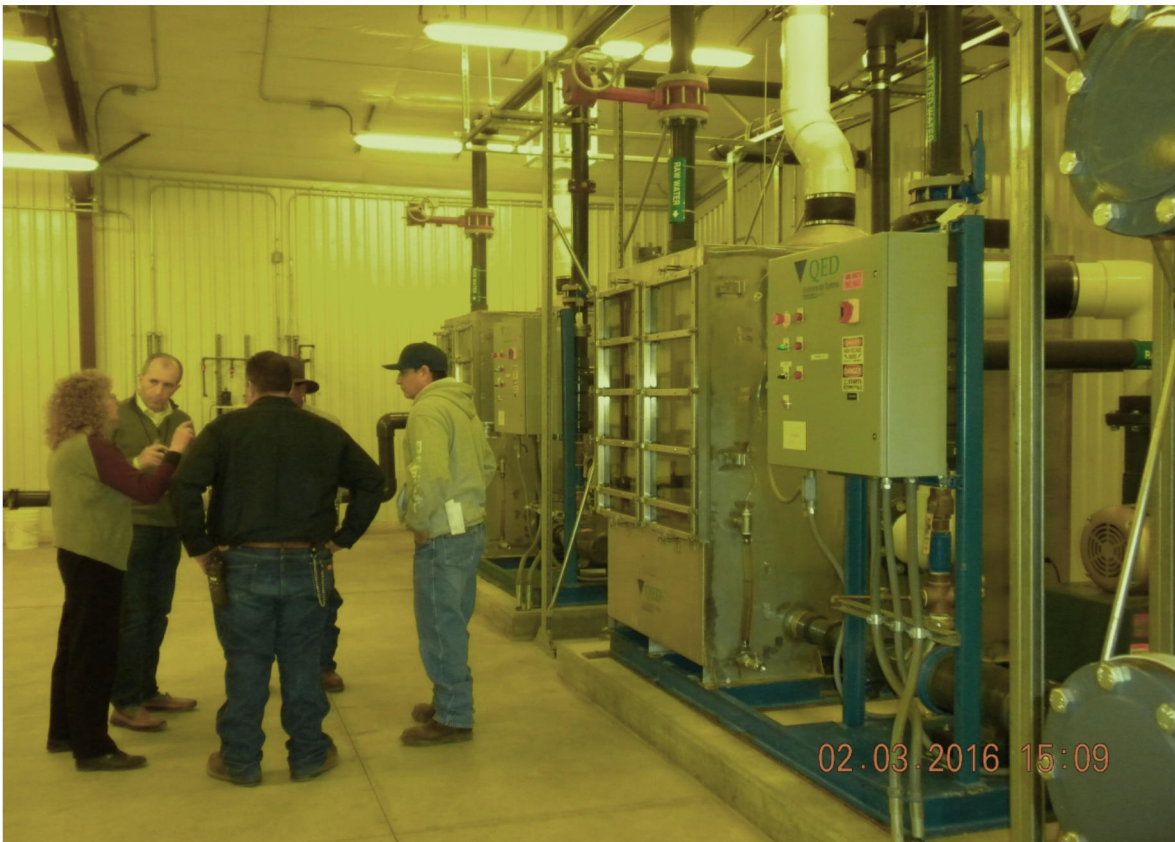
Mr. Mark Purcell (EPA-RPM), Ms. Adrienne Widmer (CLC-Utilities Administrator), and CLC-Utilities Facility Operators, discuss the remedial system operations in the main room next to the two parallel stacked-tray air strippers (South view).

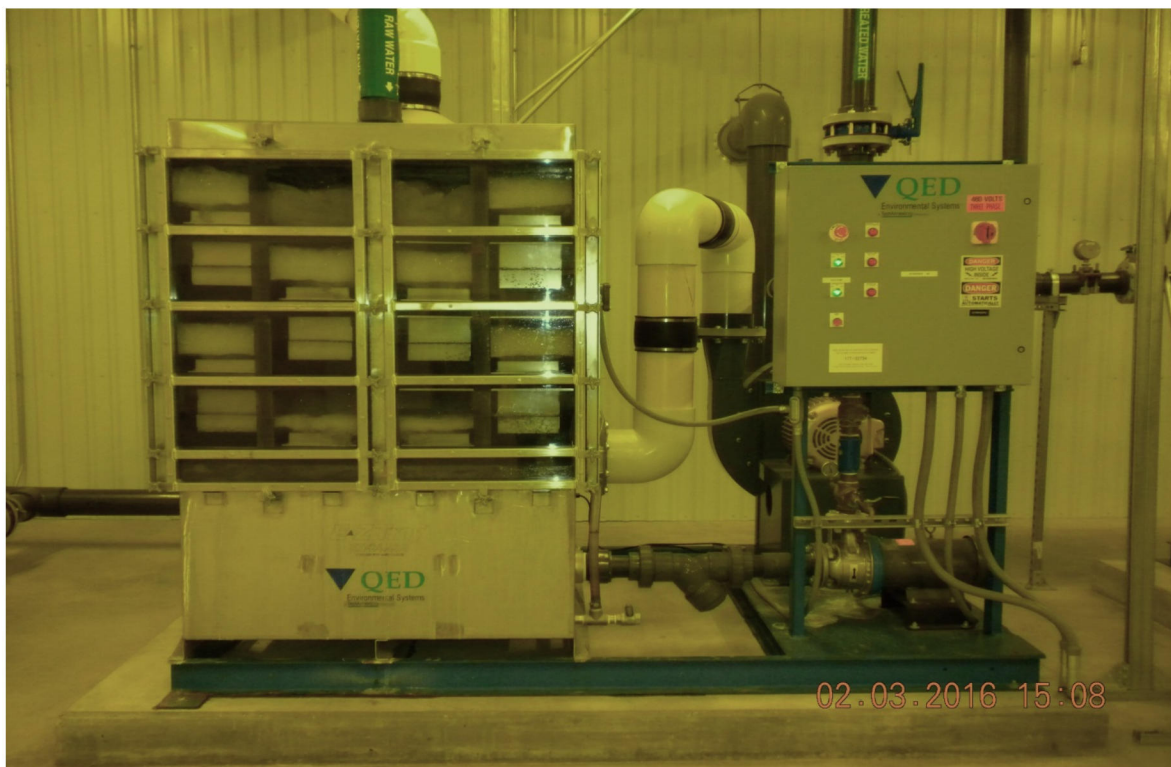
Close-up view of a QED Environmental Systems single stacked-tray air stripper and control panel, with water transfer pump and air blower that forces air through the stacked trays of untreated/raw water in the air stripper to remove VOCs (West view).

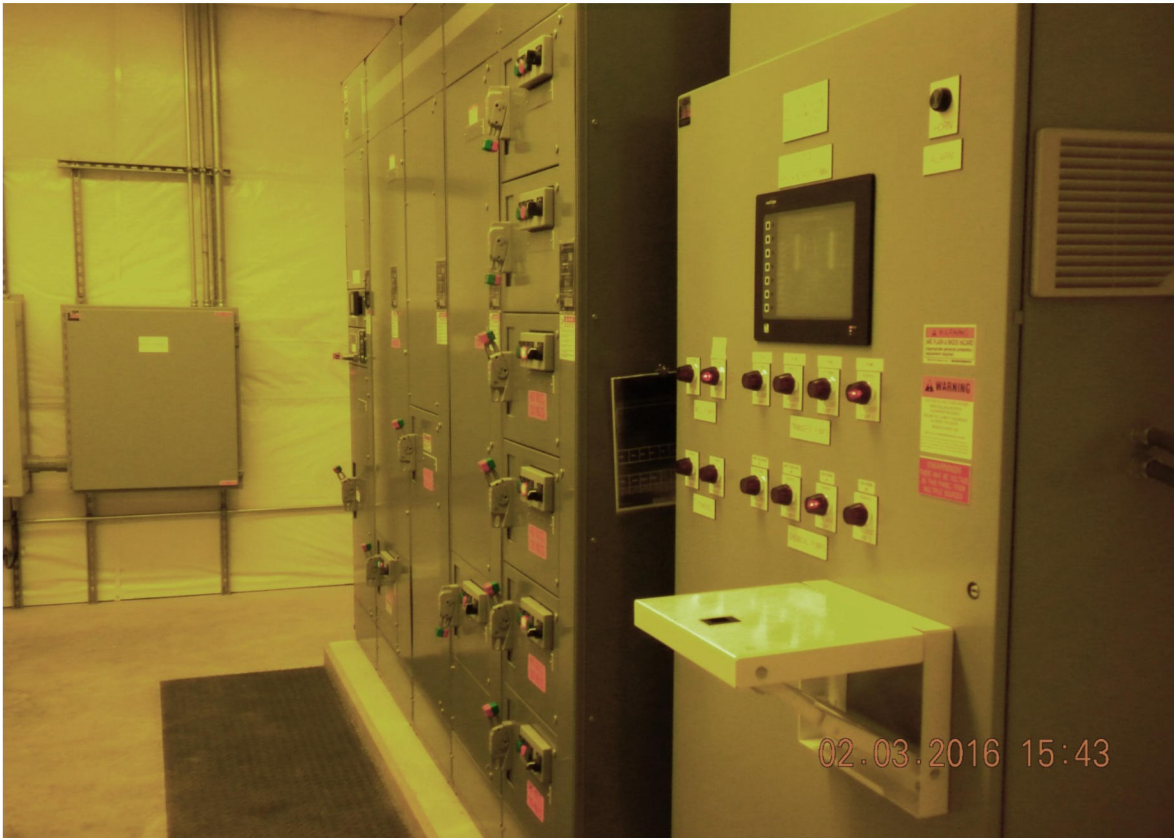
Water treatment facility process control panel inside the treatment system control room (East view).

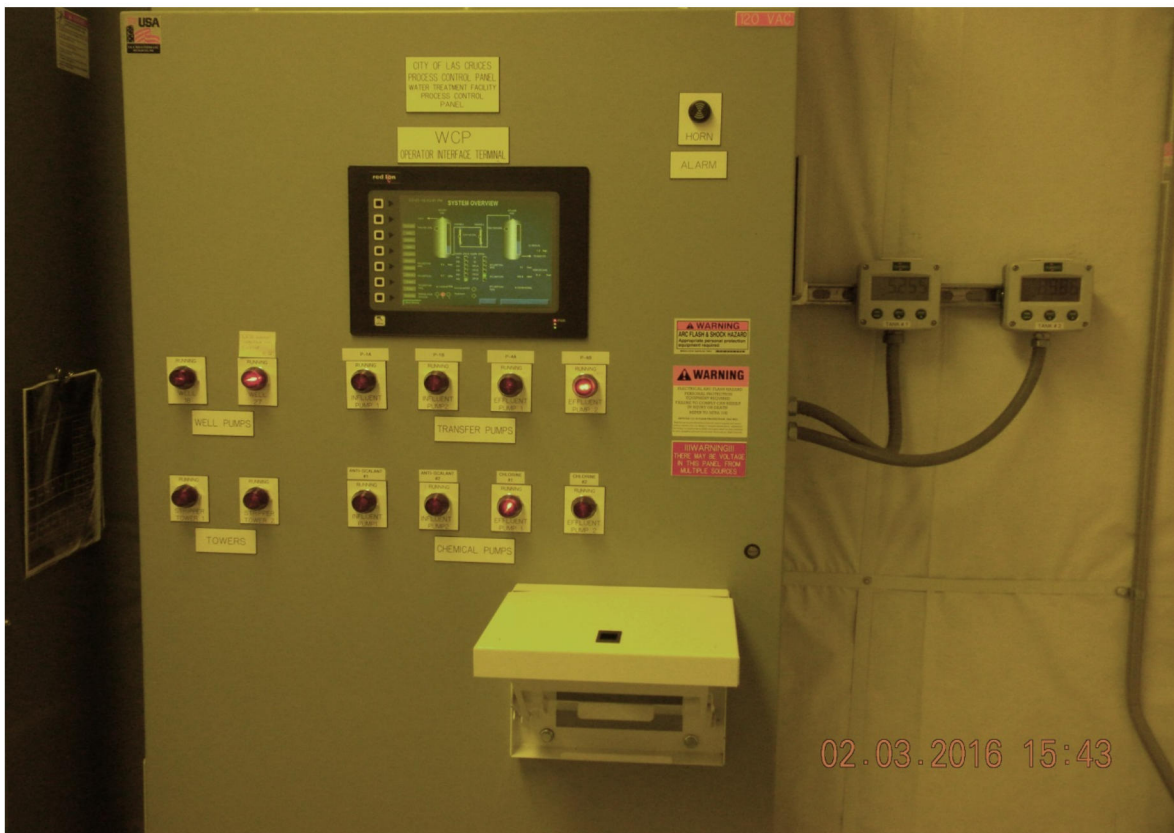
Close-up view of the water treatment facility process control panel and operator interface terminal (South view).

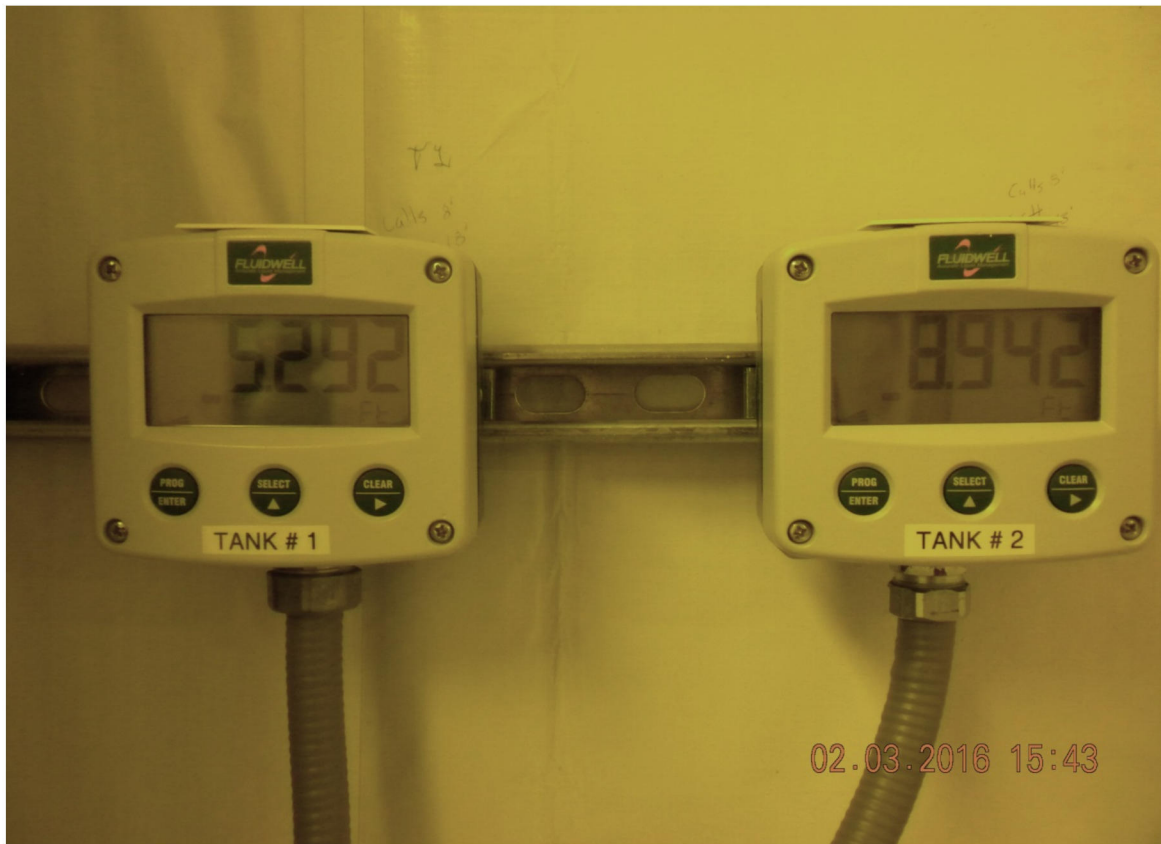
LCD monitors at the operator interface terminal indicate the water levels in the two 28,000-gallon equalization tanks (extracted/raw water and treated/finished water) (South view).

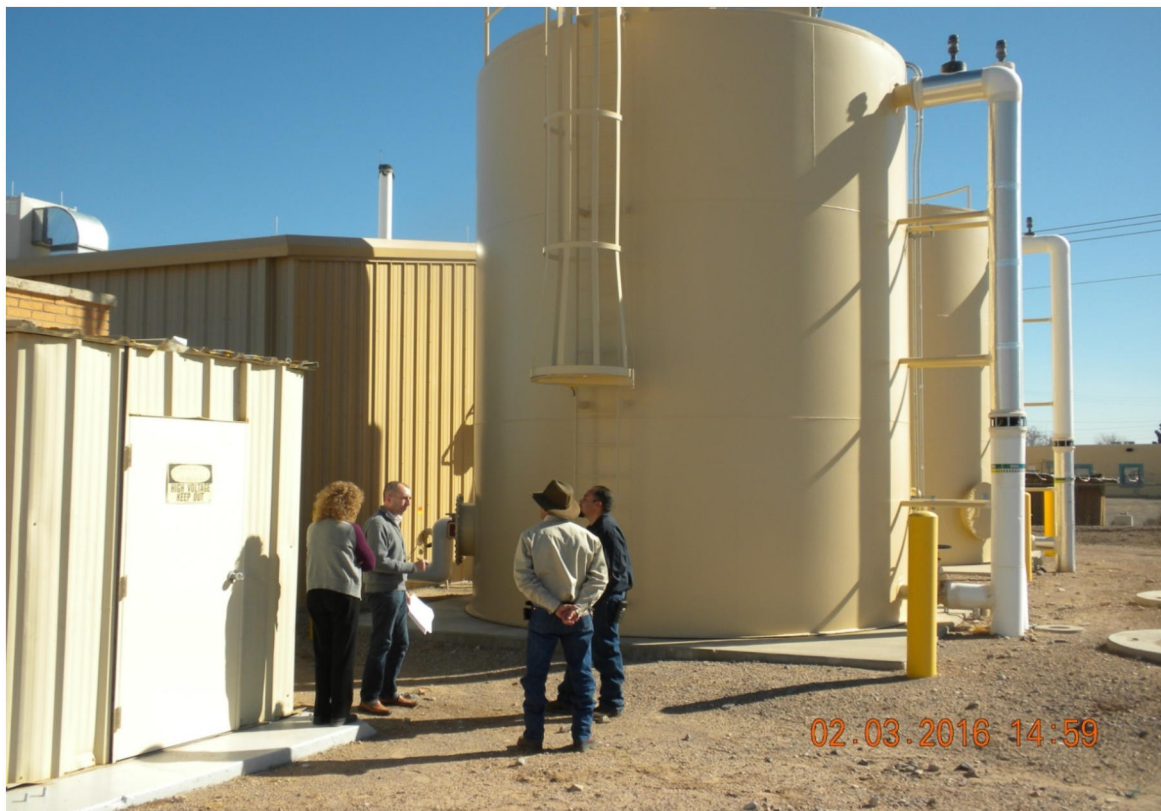
Mr. Mark Purcell (EPA-RPM), Ms. Adrienne Widmer (CLC-Utilities Administrator), and CLC-Utilities Facility Operators, discuss the remedial system operations next to the two 28,000-gallon equalization tanks on the west side of the treatment system building (South view).

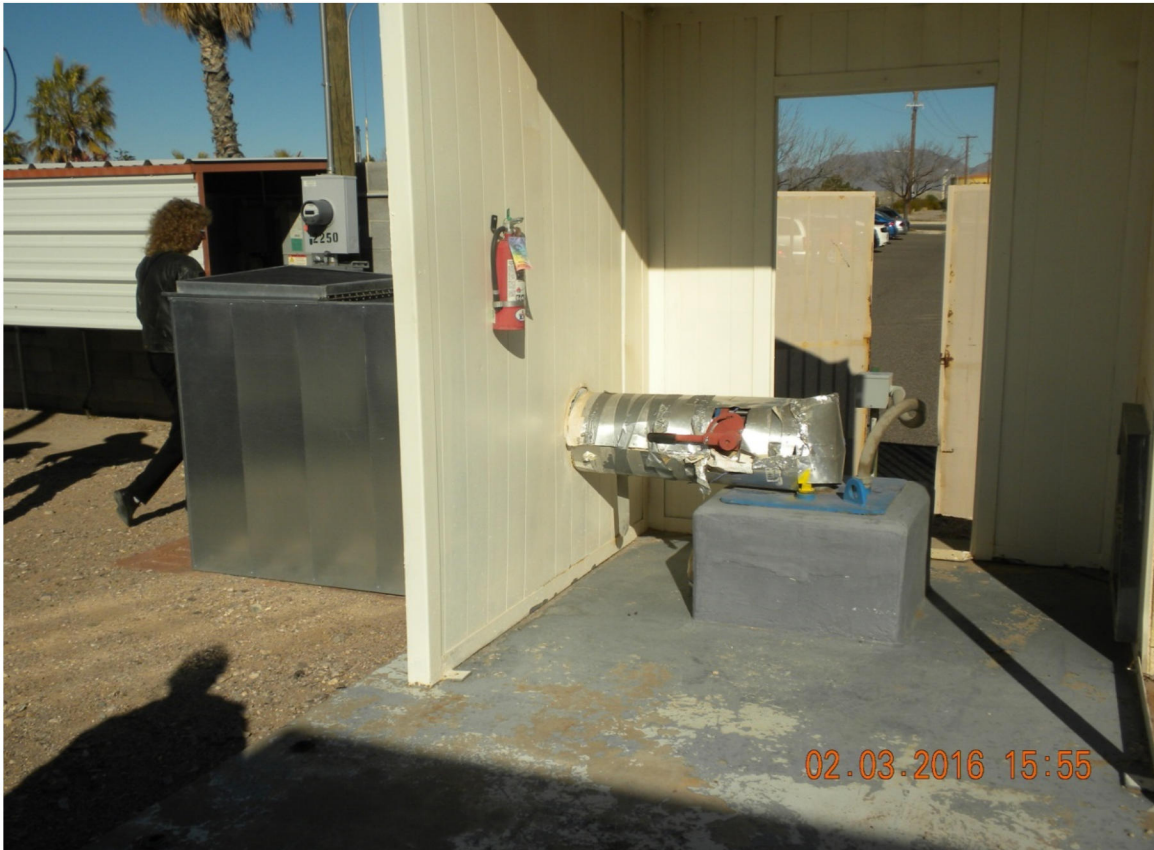
CLC Well 27 and well house enclosure located west of Walnut Street on the south side of East Griggs Avenue (East view).

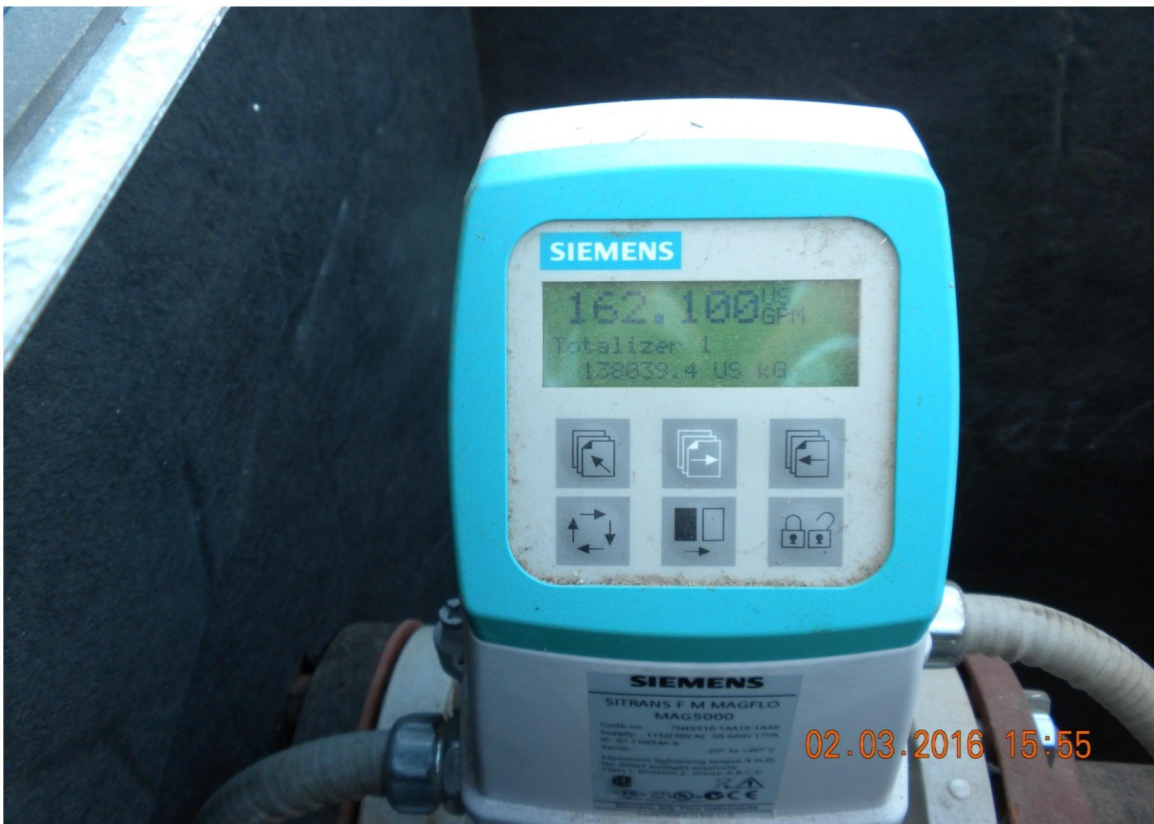
Close-up view of the water discharge flow meter at CLC Well 27 indicating an extraction rate of approximately 162 gallons per minute (West view).
